Phase I and Phase II Environmental Site Assessments, Indoor Air Quality Assessments,  
Response Plan, and DTSC Approval Letter

## ENVIRONMENTAL SITE ASSESSMENT

**2525 & 2550 Irving Street, San Francisco, CA 94122**

**ALLWEST PROJECT 18190.20**  
**February 8, 2019**

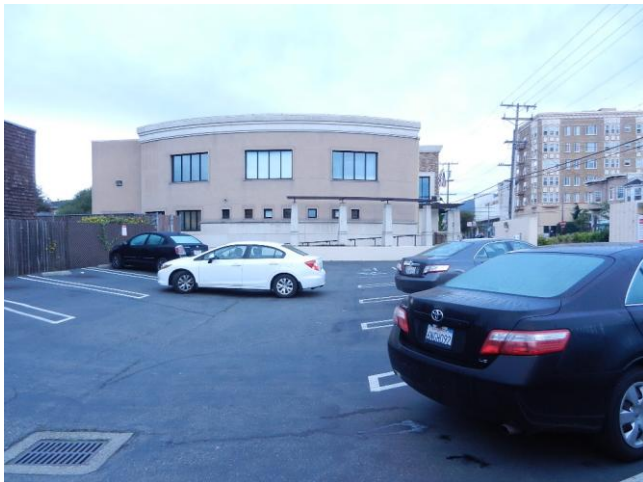
Following cessation of operations at the subject property, a 1963 aerial photograph of the 2550 Irving Street gas station location showed the concrete slabs associated with the former building and pump island(s) remaining but the structures removed. Subsequently, this area of the property was paved with the existing parking lot. AllWest identifies a moderate likelihood that USTs remain present on this portion of the parcel, and recommends performance of a UST survey.

3. Western Façade of SFPCU Building and Parking Lot/Former 2550 Irving Street Gas Station Location on Credit Union Parcel

AllWest identifies a moderate likelihood that USTs remain present on the 2550 Irving Street portion (27<sup>th</sup> Avenue/Irving Street corner) of the parcel, because concrete slab foundations of the station remained present following demolition of the gas station structures prior to paving of the area as the existing parking lot, and no construction has been completed on that area of the subject property. AllWest recommends performance of a UST survey.

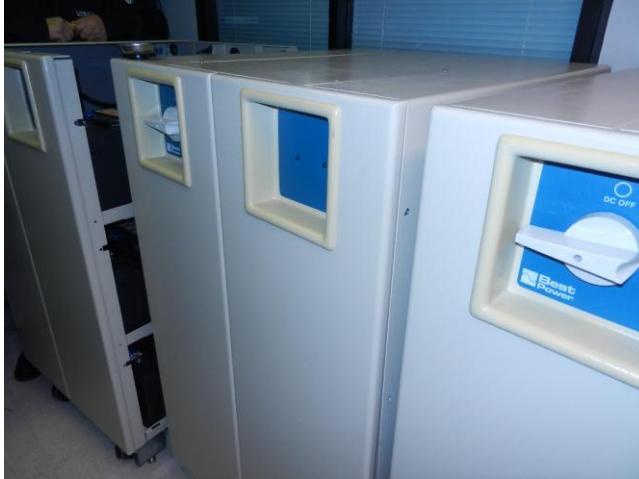
7. UPS Battery Units within SFPCU Building Server Room

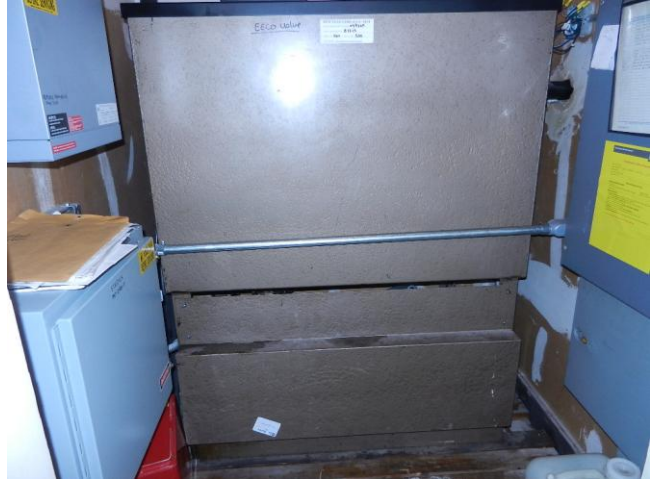
The elevator equipment room for the passenger elevator was located on the second floor and equipment room for the freight elevator on the ground floor. Visible leakage from the elevator equipment was not observed; a hydrocarbon odor was noted in the freight elevator equipment room. According to SFPCU representatives, a seal in the motor broke and was repaired in July or August 2018. Elevator machinery reportedly has never been replaced, just repaired.

8. Freight Elevator Motor in Ground Floor SFPCU Elevator Room

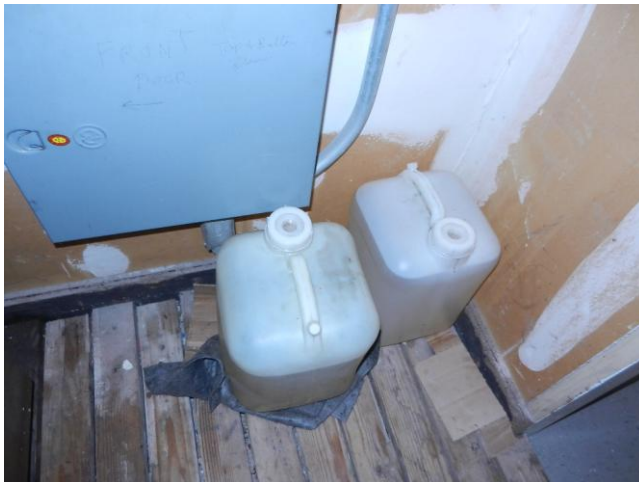
2. **STORAGE:** Regulated quantities of hazardous materials are not stored at the subject property. Two 3-gallon containers of what appeared to be hydraulic fluid were observed in the ground floor freight elevator equipment room. Several 1-quart to 5-gallon containers of paints and a few 1-gallon or smaller containers of janitorial cleaners were observed in ground and second floor janitorial closets. A UPS battery system with Halon fire suppression system was observed within the ground floor server room. Two small batteries were located within the building fire

9. Hydraulic Fluid (presumed) within Ground Floor SFPCU Elevator Room

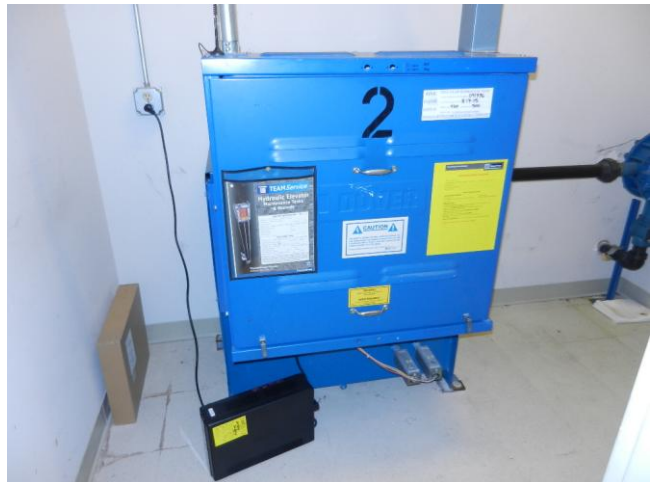
10. Passenger Elevator Motor in Second Floor SFPCU Elevator Room

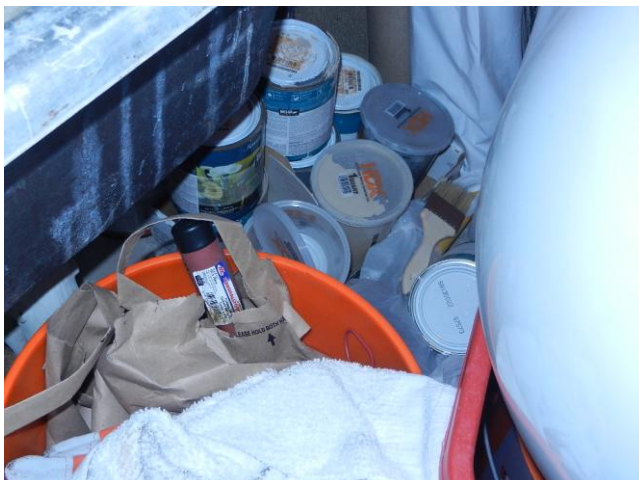
11. Paint Storage in Second Floor SFPCU Janitorial Closet

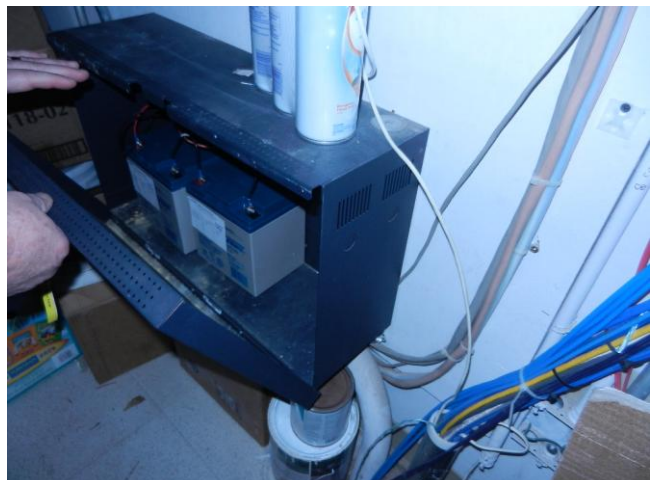
12. Batteries in Fire Alarm System in SFPCU Janitorial Closet

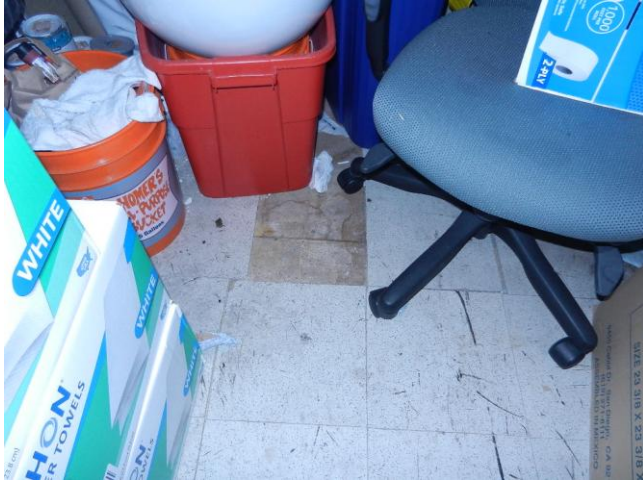
Presumed ACM would include materials installed prior to 1988 renovations conducted during tenant improvements for conversion of the building into the credit union. Materials identified in the building include wall, ceiling and flooring materials, as well as roofing materials. Additionally, the coated metal fencing panels on the parking lot parcels also are presumed ACM. Observed materials generally appeared in good condition. Some damaged floor tile was observed in the second-floor janitorial closet.

13. Damaged Floor Tile in SFPCU Janitorial Closet

It is recommended an asbestos-containing building materials (O&M) program be implemented. An O&M program details procedures designed to ensure that the asbestos containing building materials, whenever possible, remain undisturbed to minimize the likelihood of exposing building tenants and workers to airborne asbestos fibers.

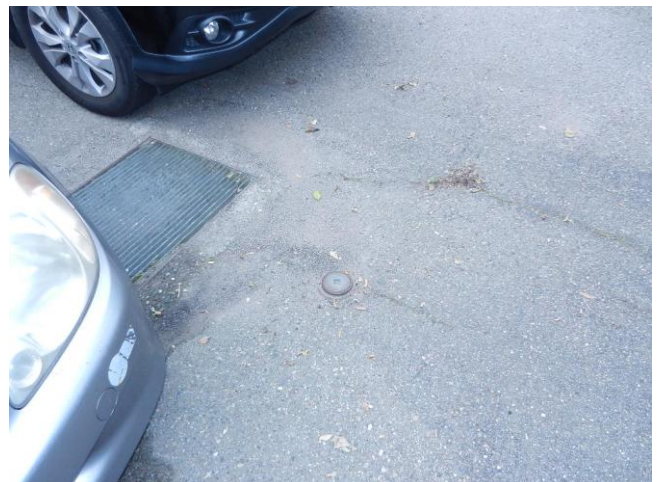
8. **SUMPS:** Sumps were not observed on the subject property.
9. **STORM WATER DRAINS:** Storm water drains were observed in the parking lot and credit union parcel parking lots. A capped, approximately 3-inch diameter steel pipe flush with the ground surface adjoined the storm drain in the parking lot parcels; the structure appeared associated with a pipe within the drain catchment.

18. Storm Drain with Presumed Adjoining Cleanout on  
Parking Lot Parcels

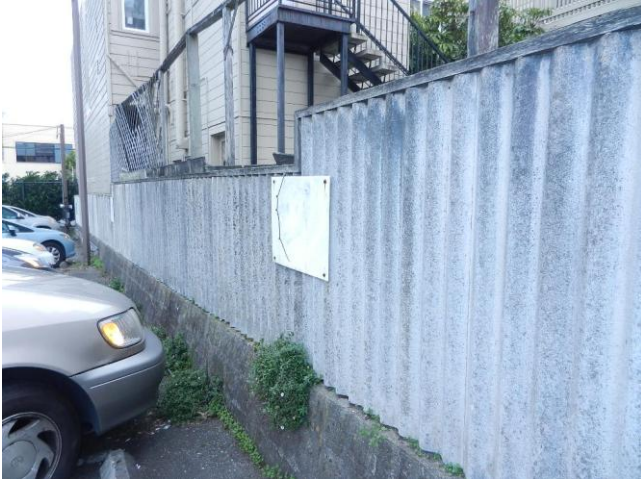
19. Potentially ACM-Containing Perimeter Fencing on Parking Lot Parcels
