Pre-Demolition Hazardous Materials Survey

**730 Stanyan Street
San Francisco, CA 94117**

June 7, 2018

Terracon Project No. R1187355

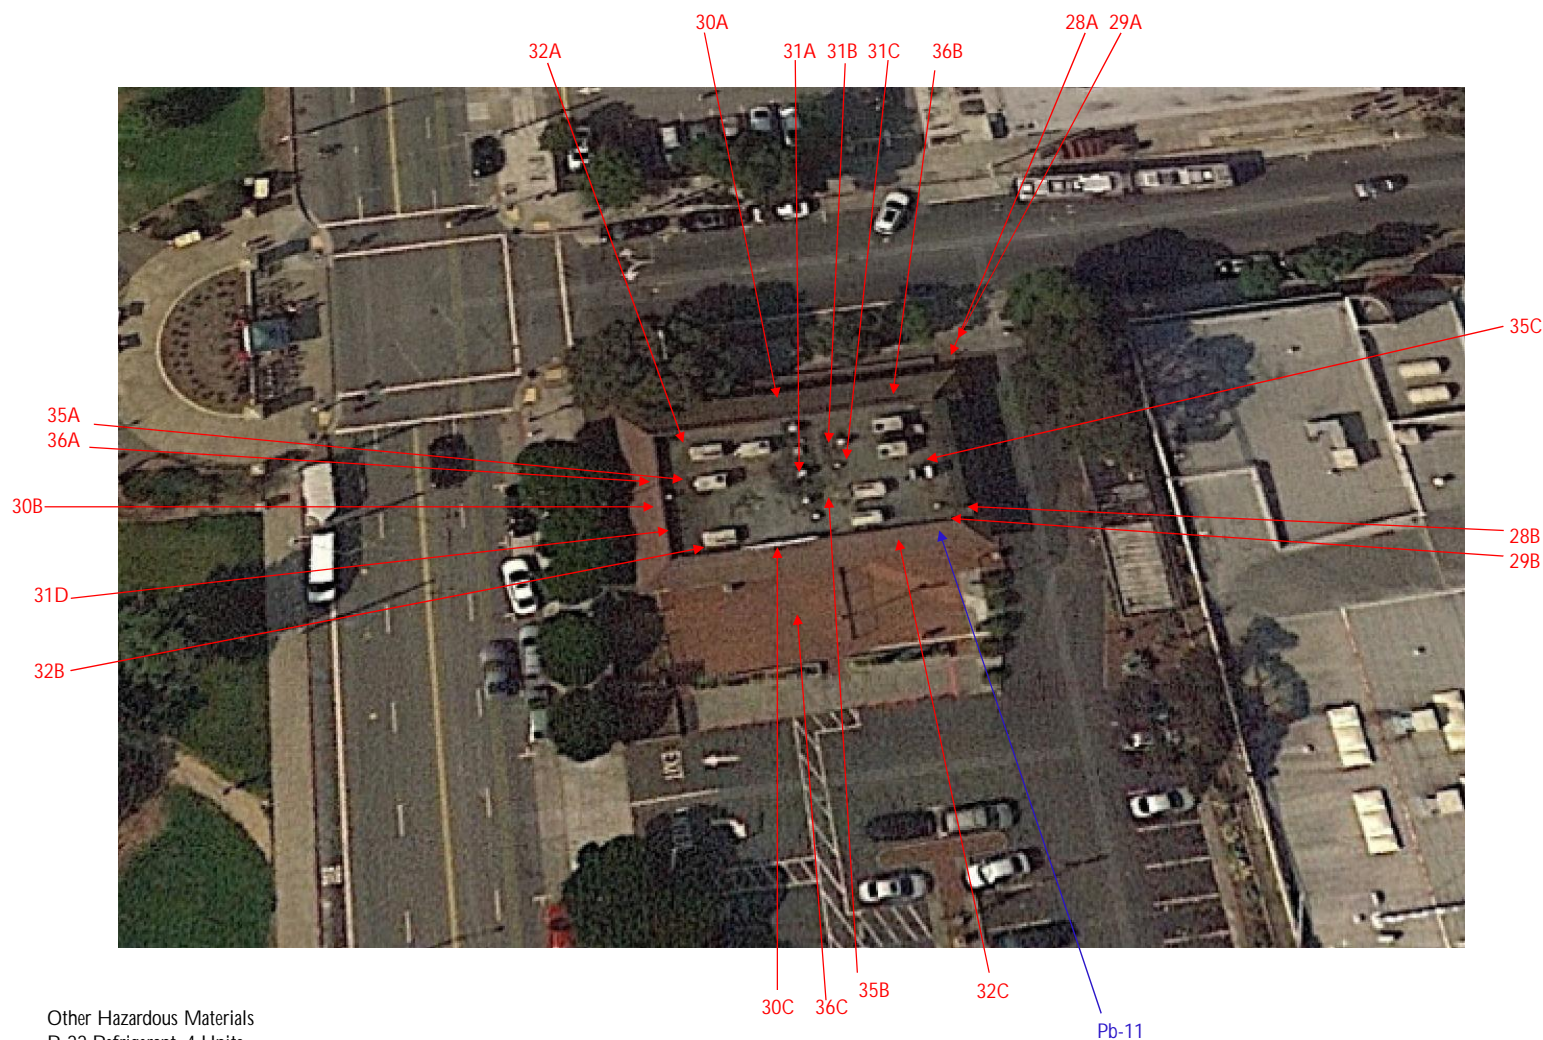
| Figure 3 |

Other Hazardous Materials
R-22 Refrigerant: 4 Units
Unknown Refrigerant: 4 Units
4' Ballasts: 20
4' Mercury Tubes: 40

- n Roof level HVAC systems were observed to be serviced by R-22 and unknown coolants. These materials should be reclaimed prior to disposal of affected units.

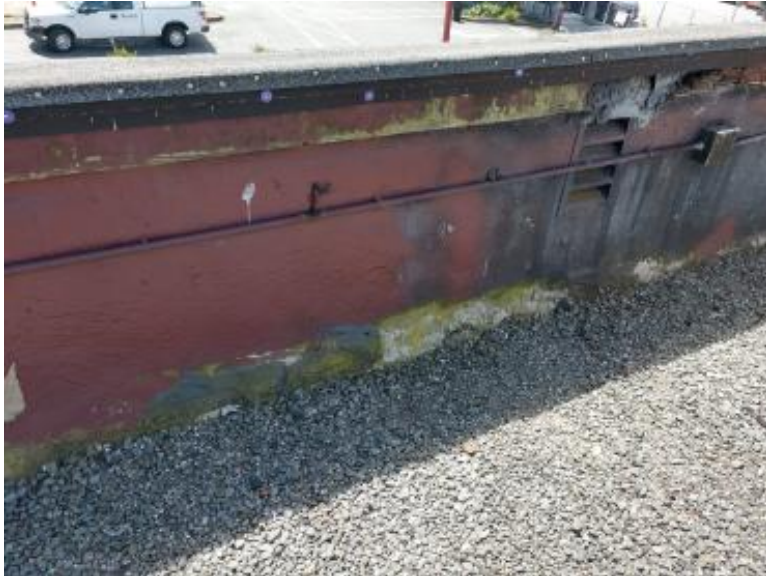
Photo 1 Caption: HMs 30/35 - Main Roofing Field and Parapet

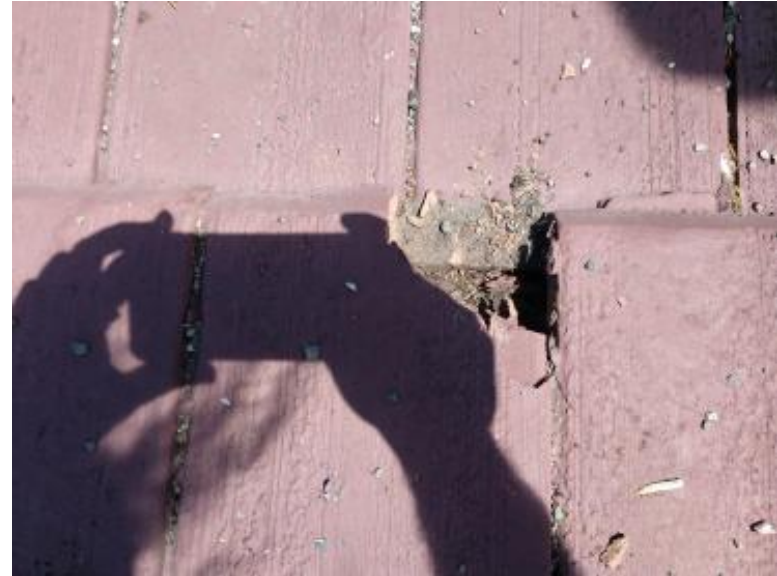
Photo 2 Caption: HMs 28/29 - Clay Tile Roofing Field with Felt Layer

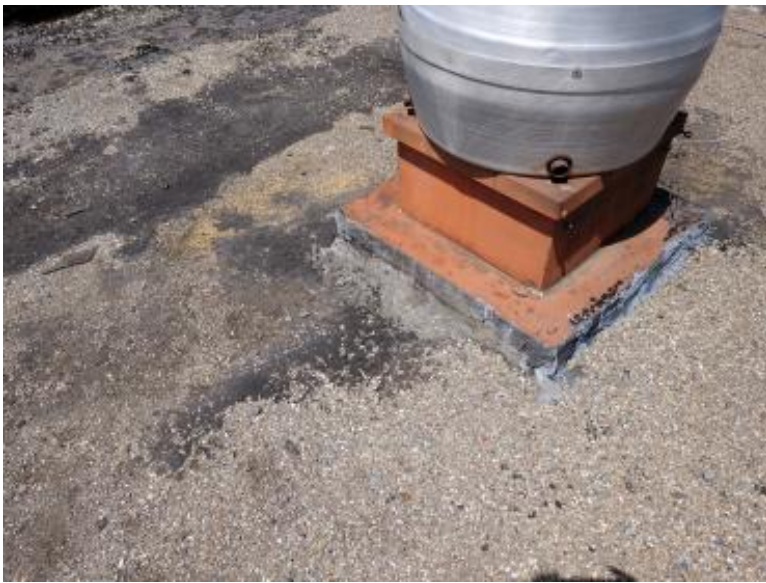
Photo 3 Caption: HMs 31/32 - Roof Curbing with ACM Roof Mastic

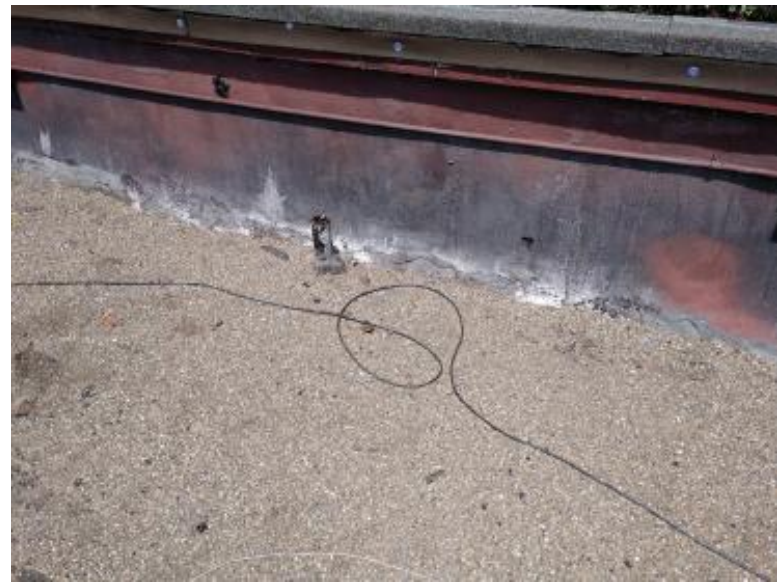
Photo 4 Caption: Main Roofing Field with ACM Roof Mastics

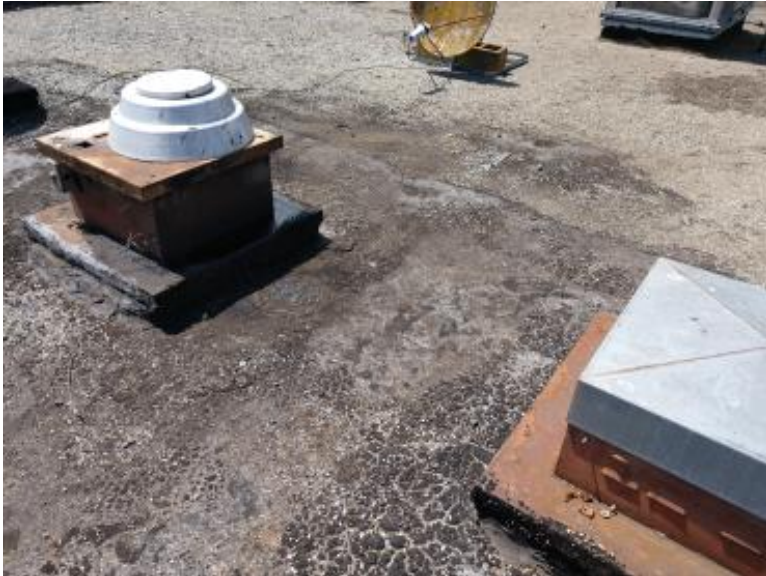
Photo 5 Caption: ACM Roofing Mastics on Main Roofing Field

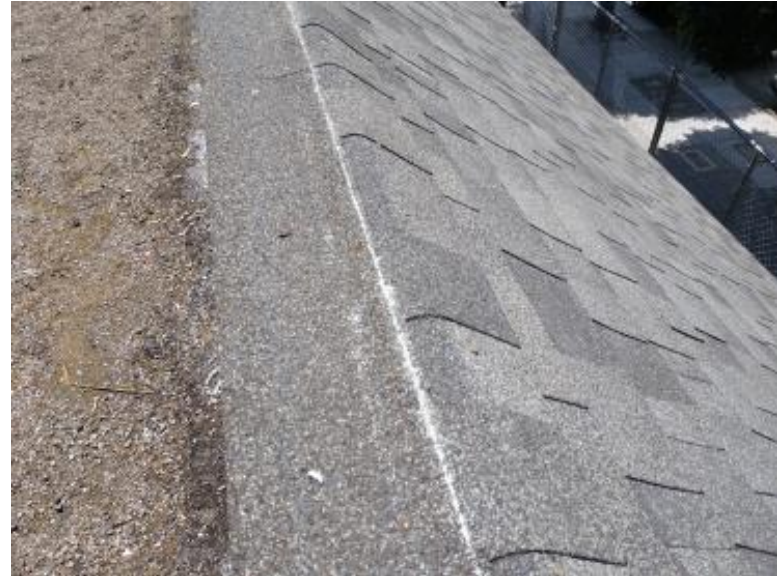
Photo 6 Caption: HM 36 - Perimeter Roofing Field System

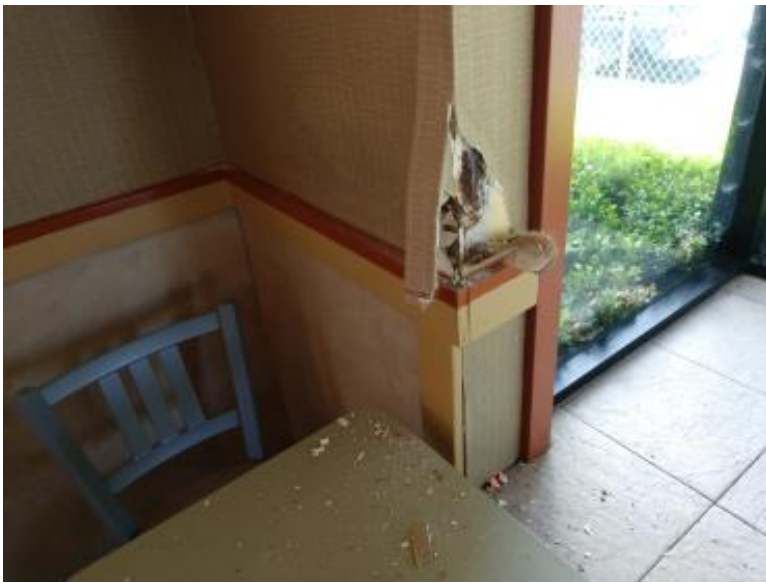
Photo 7 Caption: Tan Wall Covering, Perimeter Greenboard

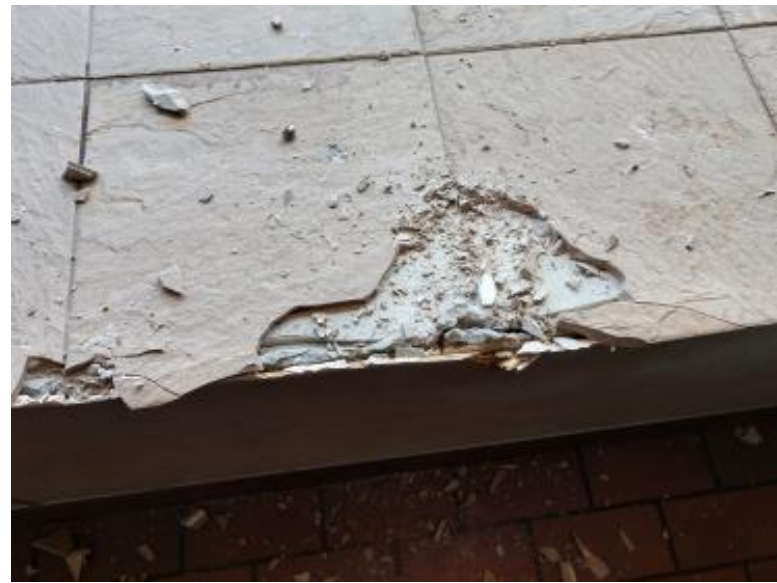
Photo 8 Caption: HM 2 - Faux Stone Ceramic Tile System

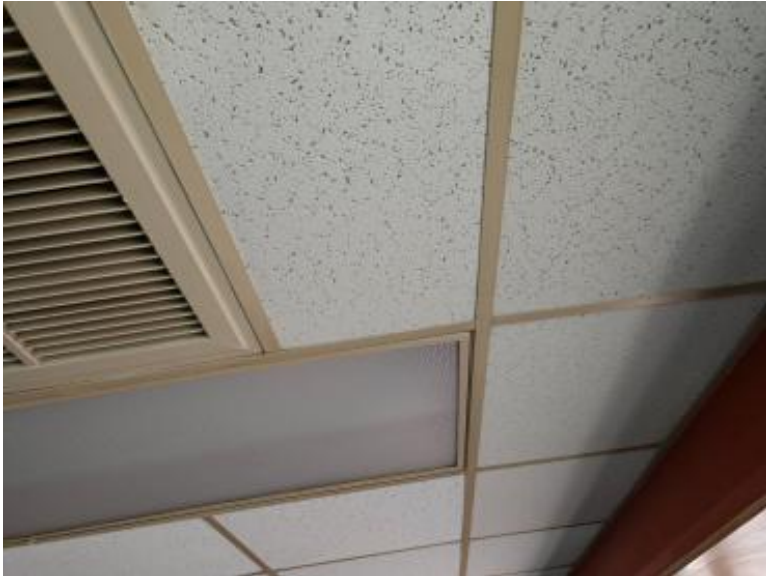
Photo 9 Caption: HM 3 - Lay-in Ceiling Tile System

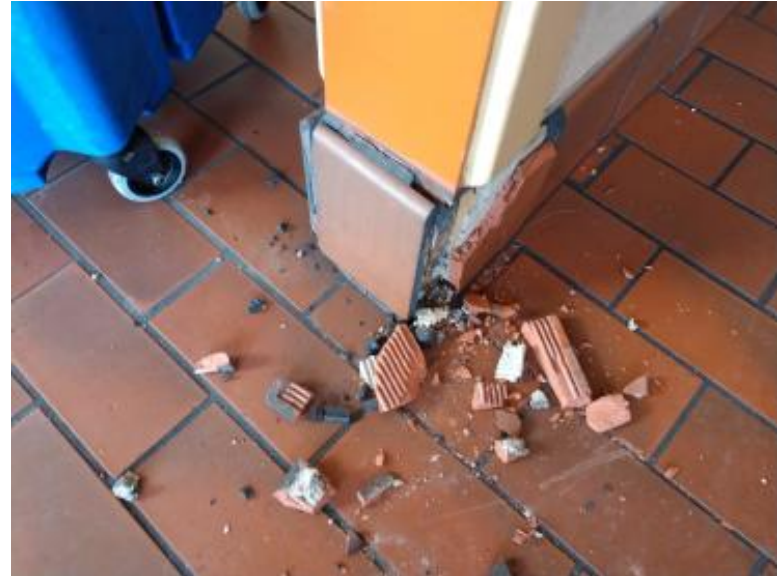
Photo 10 Caption: HMs 5/6 - Ceramic Tile Cove and Flooring Systems

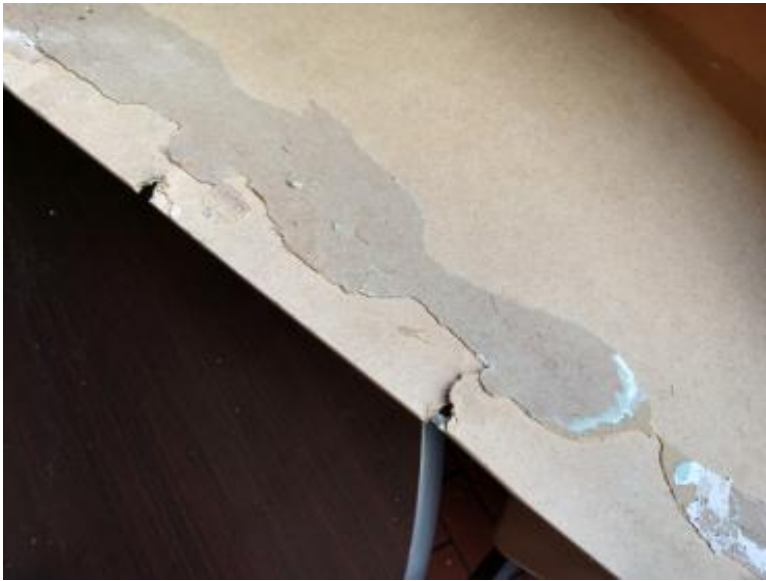
Photo 11 Caption: HM 16 - Wood Paneling Adhesive

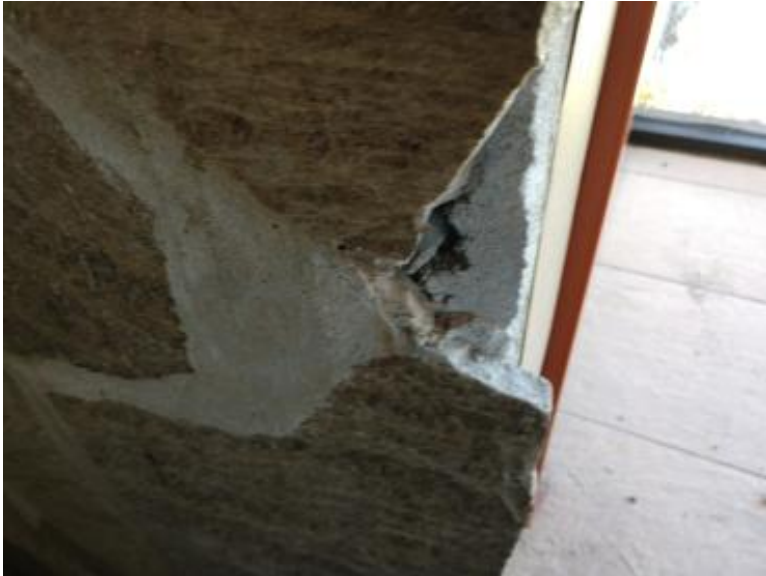
Photo 13 Caption: HM 34 - Decorative Rock Wall Mortar

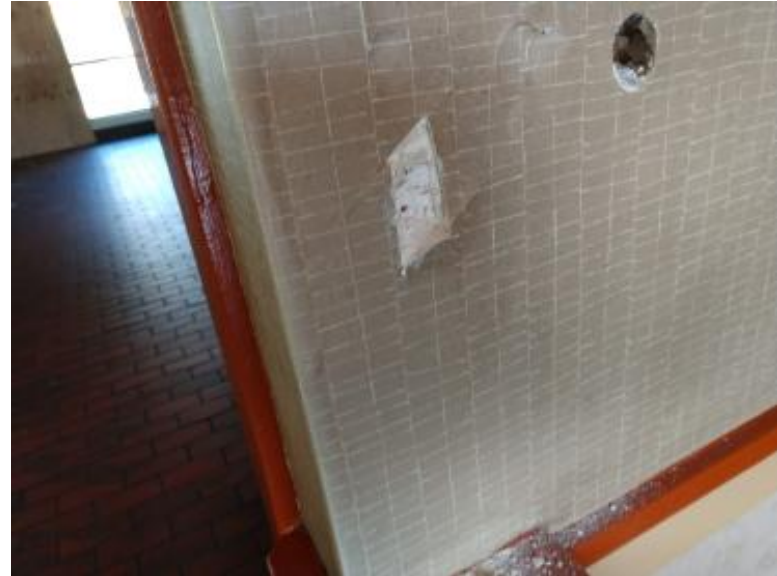
Photo 14 Caption: HM 33 - Tan wall Covering

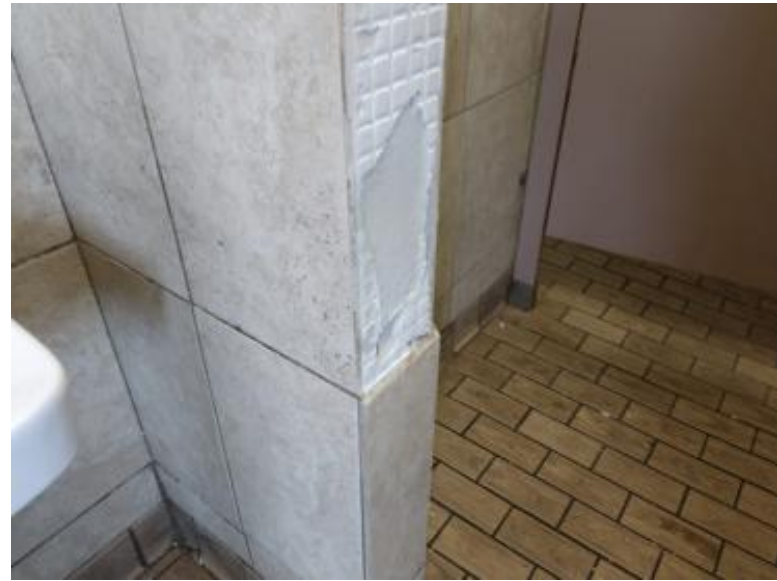
Photo 16 Caption: HMs 10/15 - Restroom Ceramic Tile Systems

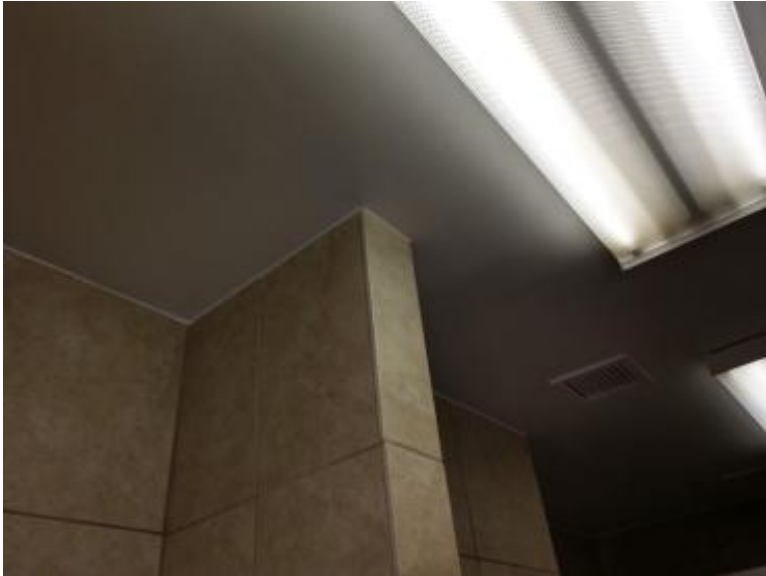
Photo 17 Caption: HM 15 - Restroom Ceramic Wall Tile

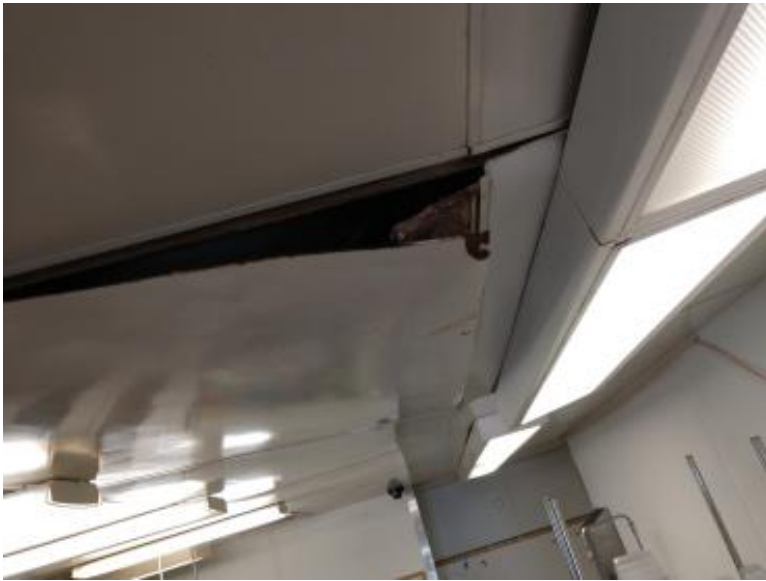
Photo 19 Caption: HM 12 - 4' Glued on Ceiling Tiles

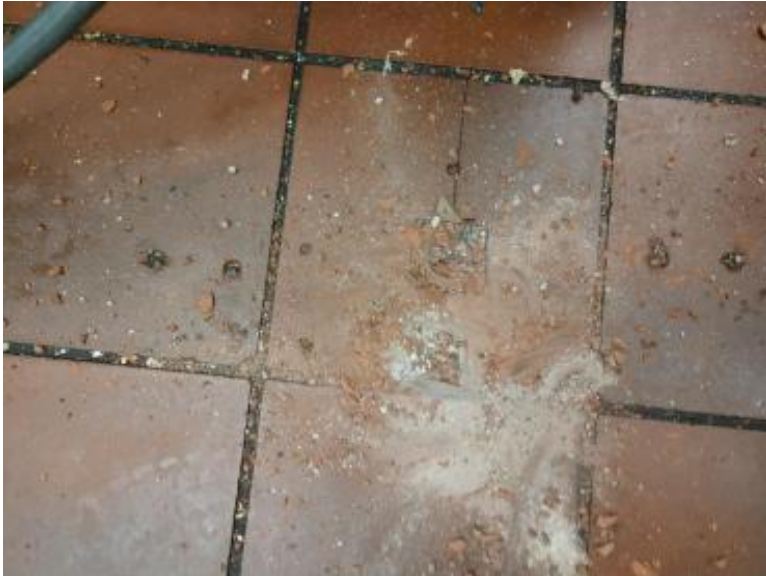
Photo 21 Caption: HM 9 - 9" Ceramic Floor Tile

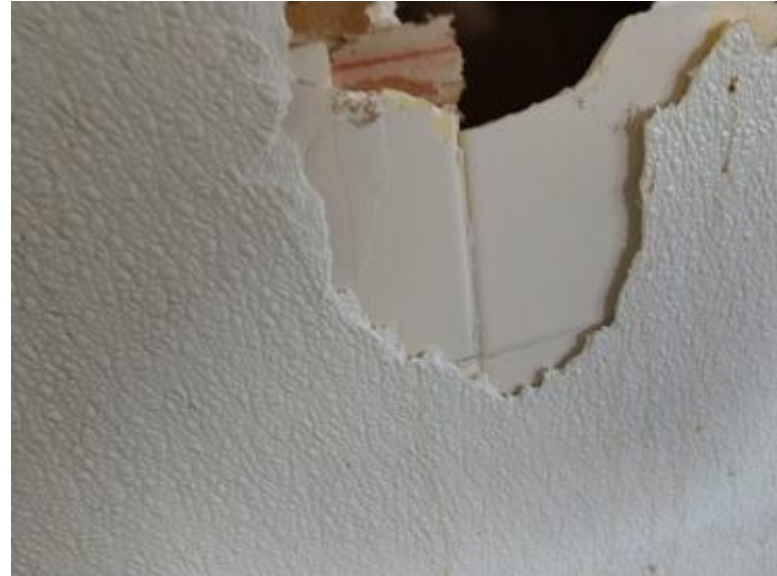
Photo 22 Caption: HM 7 - FRP Wainscot System

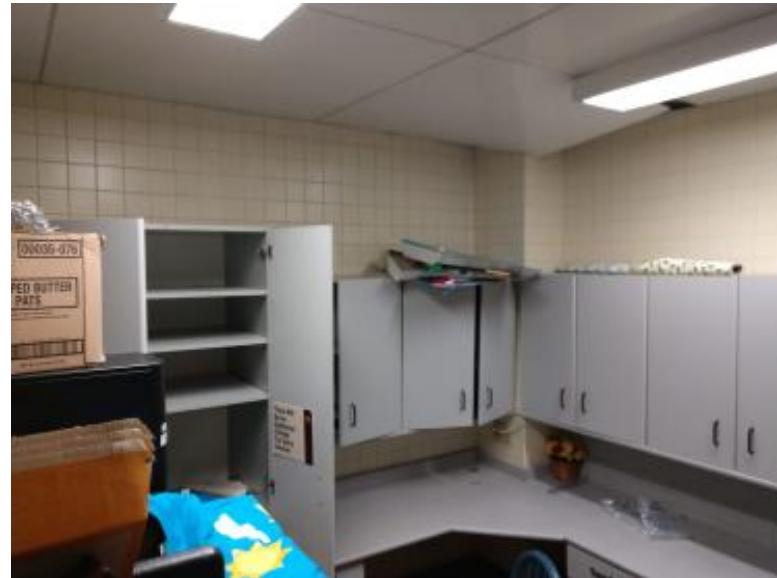
Photo 24 Caption: HM 8 - Ceramic Wall Tile System

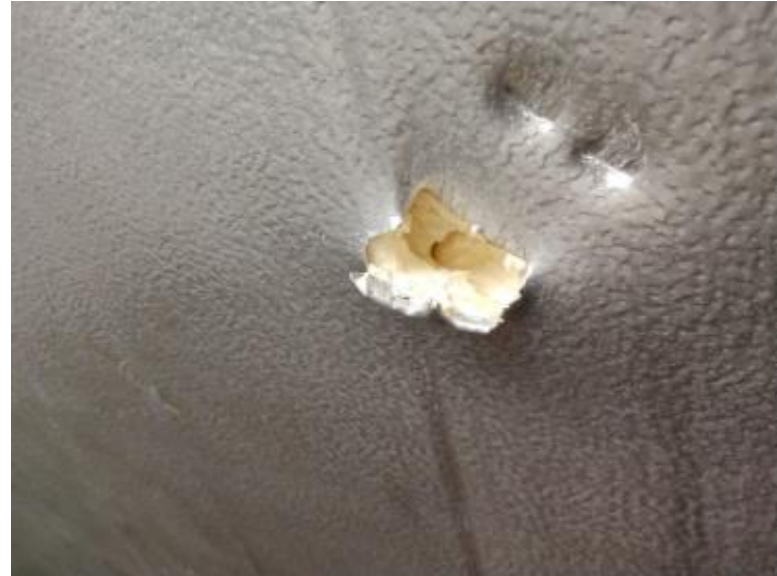
Photo 26 Caption: HM 17 - Refrigerator Foam Insulation

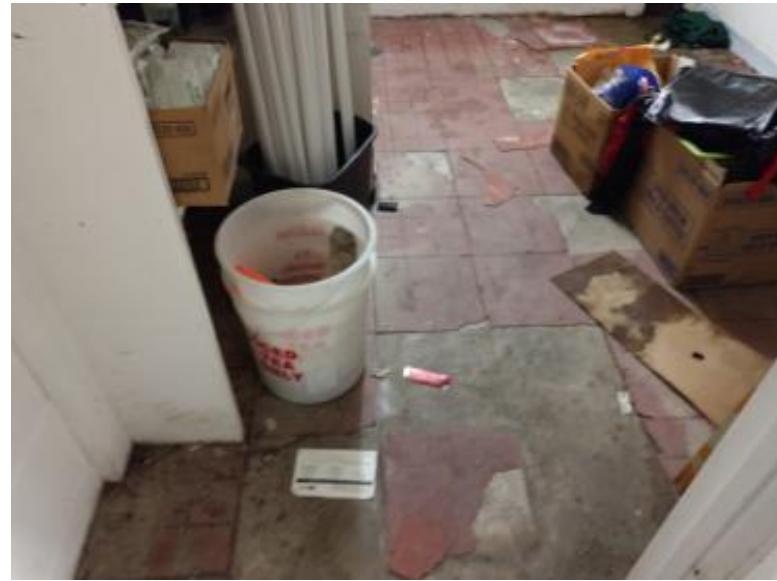
Photo 28 Caption: HM 20 - Red Press on Floor Tile

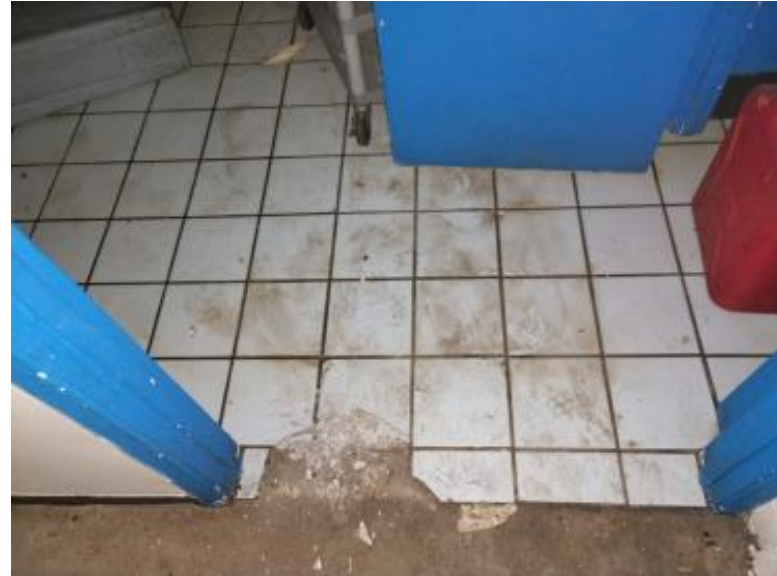
Photo 30 Caption: HM 19 - White Ceramic Floor Tile System

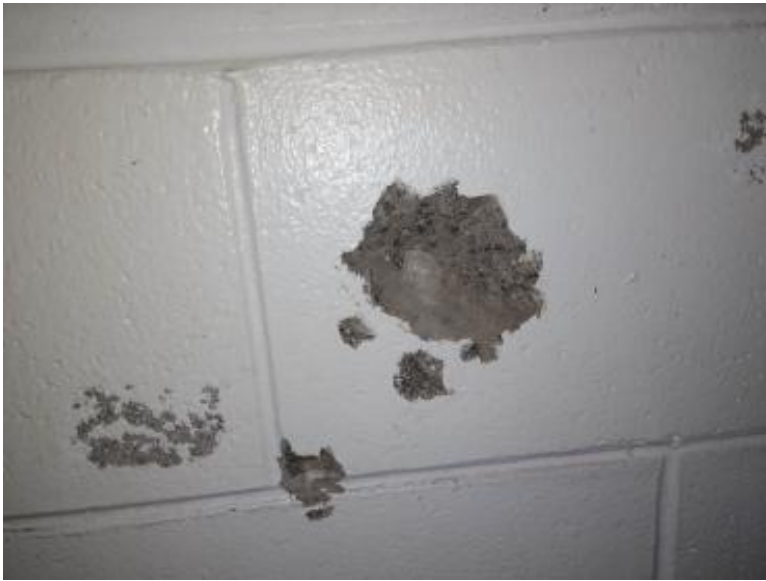
Photo 31 Caption: HMs 23/24 - Cinderblock Wall Systems

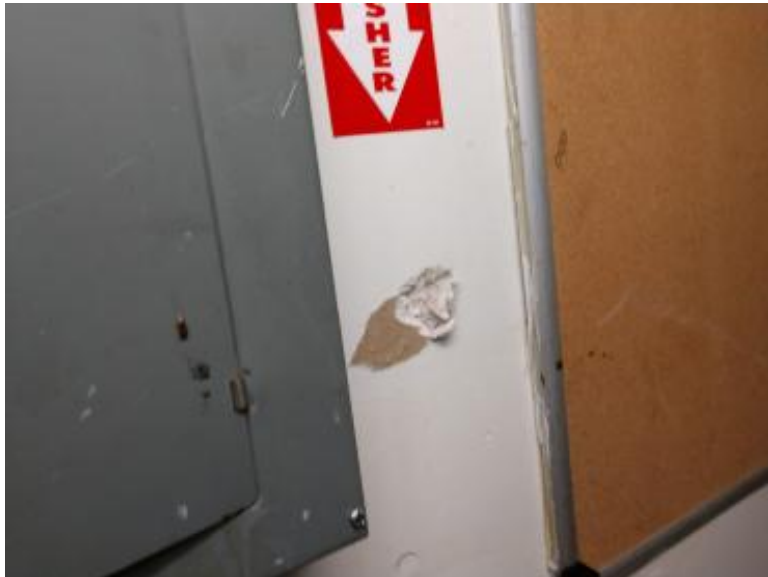
Photo 33 Caption: HM 13 - Drywall Wall System (ACM)

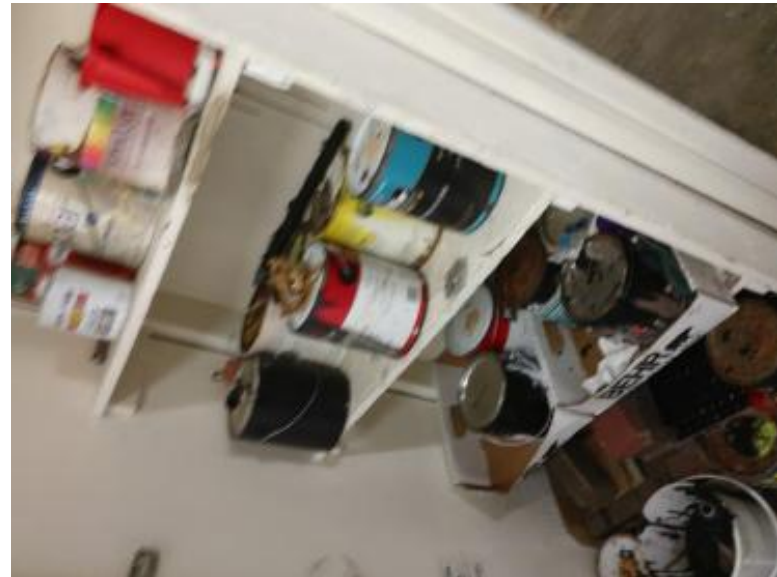
Photo 34 Caption: Abandoned Paints/Chemicals

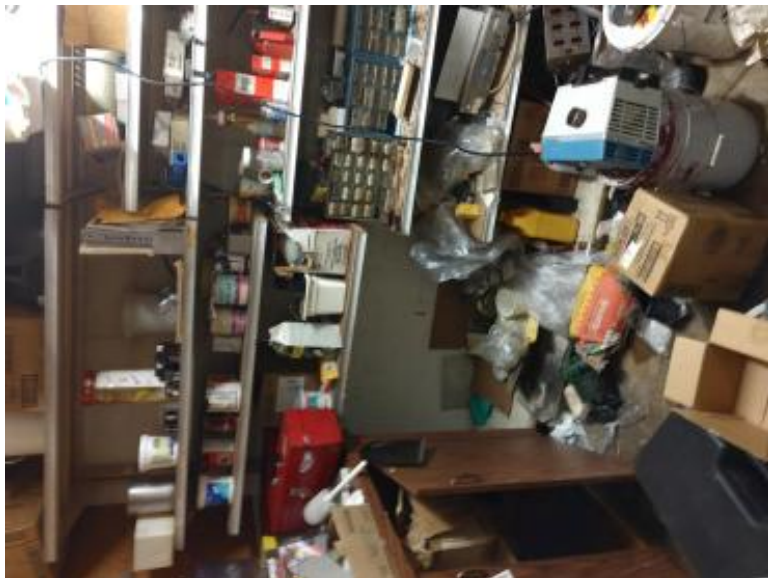
Photo 35 Caption: Abandoned Maintenance Supplies

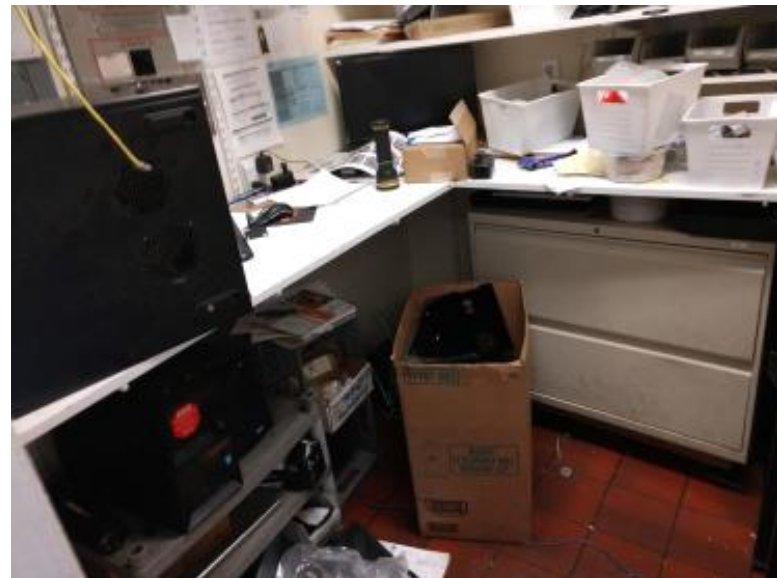
Photo 36 Caption: Select Universal Wastes

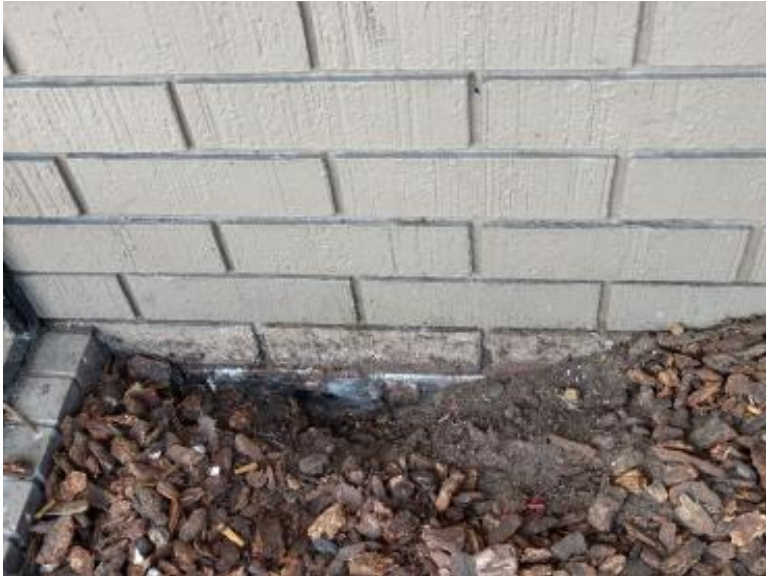
| Sample Nos. / Material Description | Material Location | NESHAP Category | Cal-OSHA Class | Asbestos Type | Estimated Quantity* |
|--|--|---|---|---|---|
| 37A, B & C / Planter Box Moisture Barrier - Black | Material is Limited to Exterior Planter Boxes | Cat. II | Class II | 25% CH | 400 sf |

Photo 37 Caption: Planter Box Moisture Barrier (ACM)

Category I Non-Friable materials can be reasonably expected to be damaged and made friable during normal demolition activities and should be removed prior to start of demolition. Category II Non-Friable materials are likely to be damaged and made friable during demolition or renovation activities and must be removed prior to start of demolition. All removal of ACMs including non-friable materials left in the building must be conducted by a licensed and registered asbestos abatement contractor in accordance with 8CCR1529 and the BAAQMD Regulation 11 Rule 2.

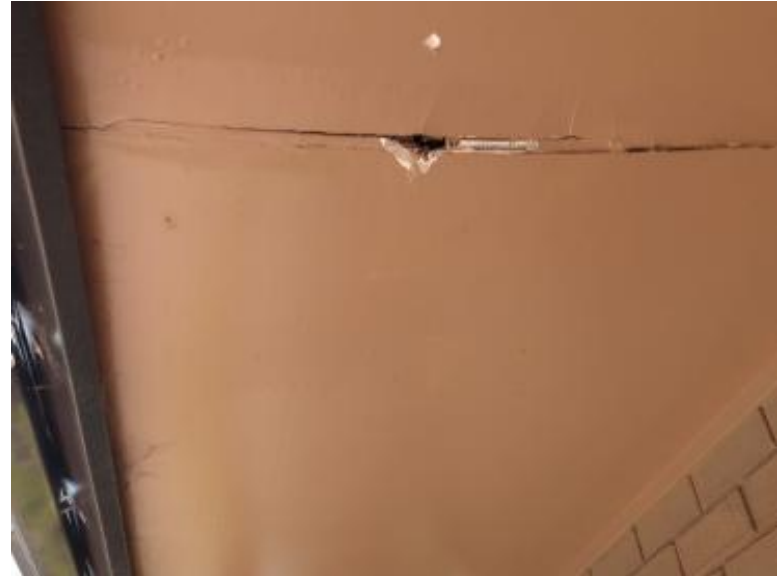
Photo 38 Caption: HM 25 - Exterior ACM Eave System

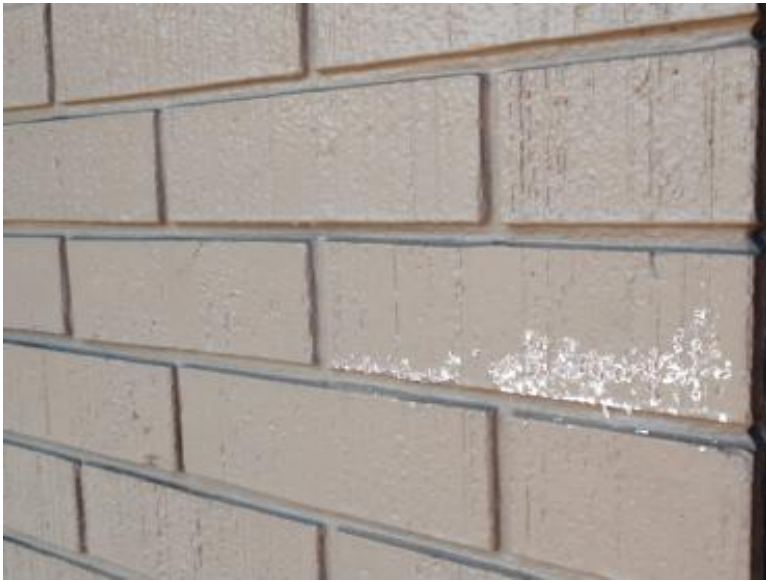
Photo 39 Caption: HM 18 - Exterior Brick Wall System
