Phase I Environmental Site Assessment

**490 South Van Ness Avenue
San Francisco, California**

**Rincon Consultants, Inc.
July 2, 2015**

**Phase I Environmental Site Assessment - ASTM 05 & 13
490 South Van Ness Avenue, San Francisco, California**

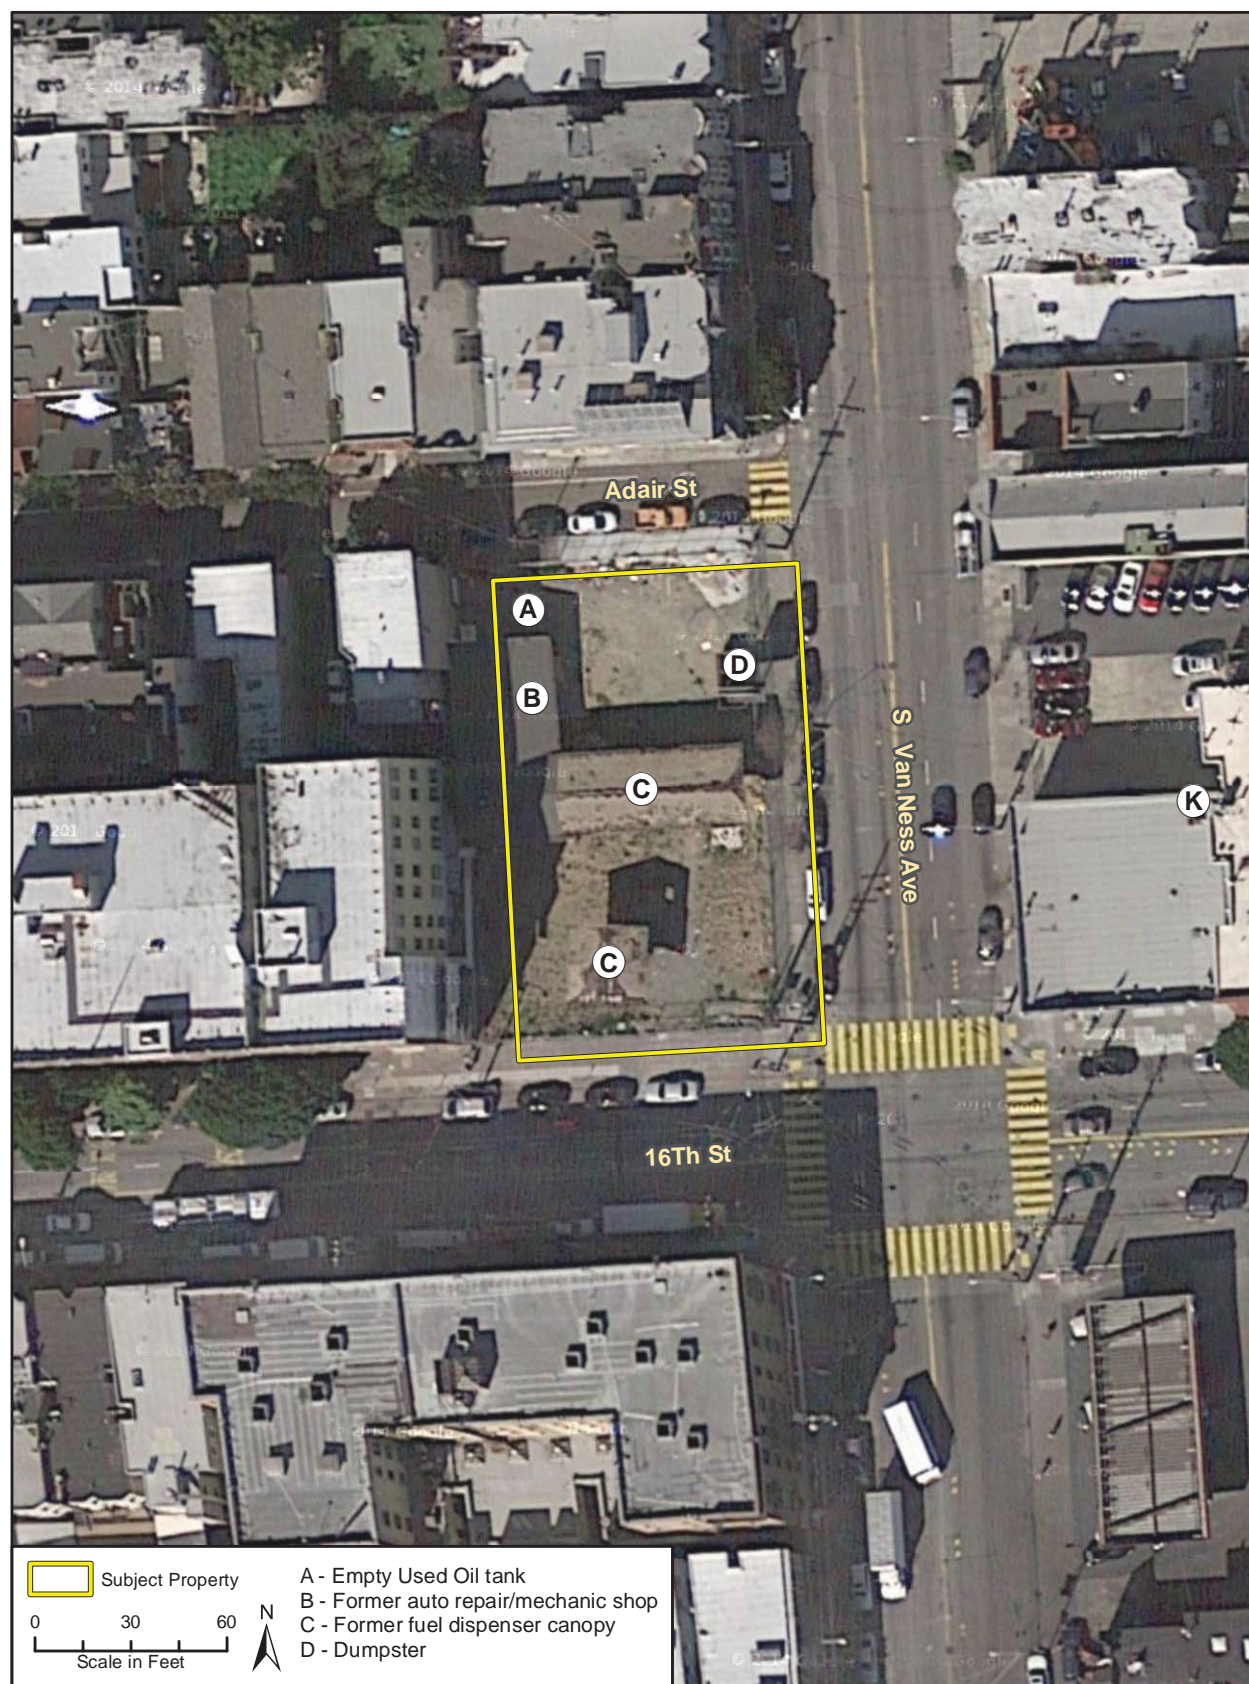
Figure 2

Site Map

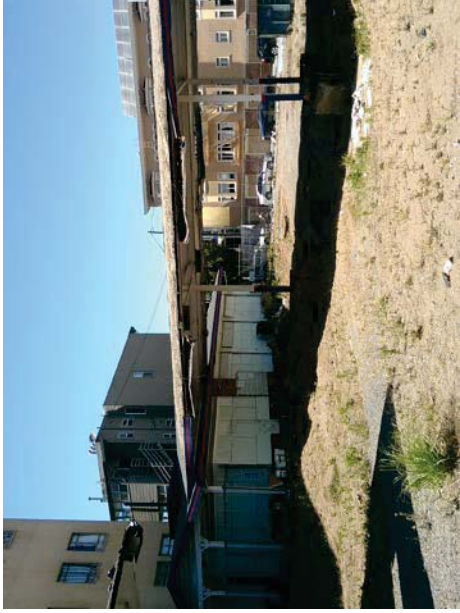
Photograph 1. View of the subject property looking north from 16th Street and South Van Ness Avenue. The northern adjacent residential properties are visible in the background

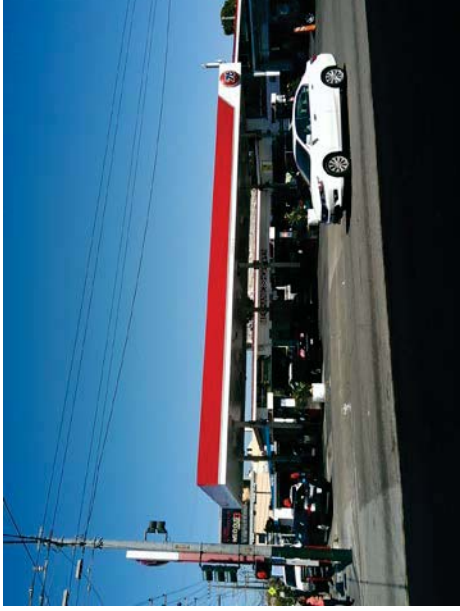
Photograph 2. View of the current 76 gas station located at the south east corner of 16th Street and South Van Ness Avenue.

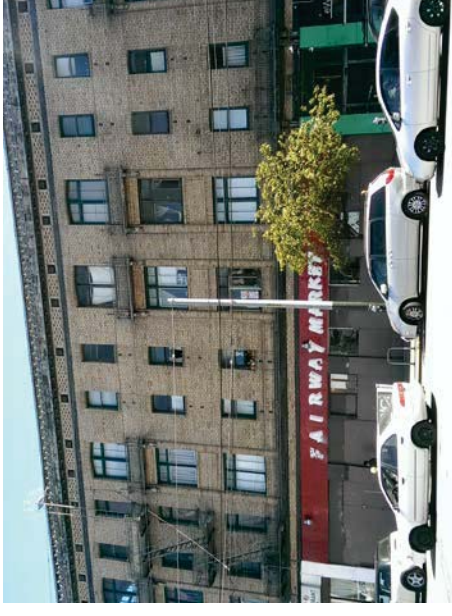
Photograph 3. View of southern adjacent properties across 16th Street.

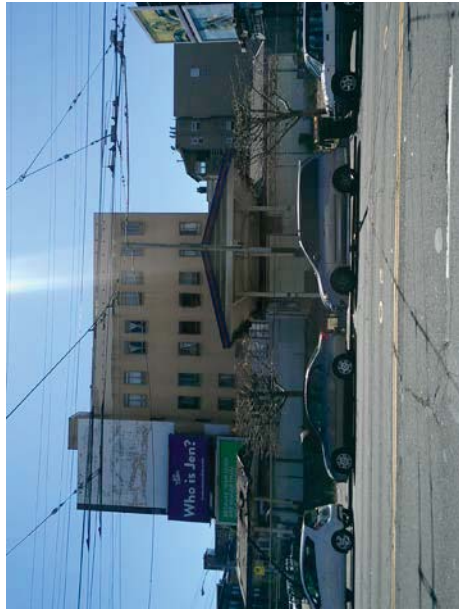
Photograph 4. View of the subject property looking west across South Van Ness with the mixed residential and retail properties behind.

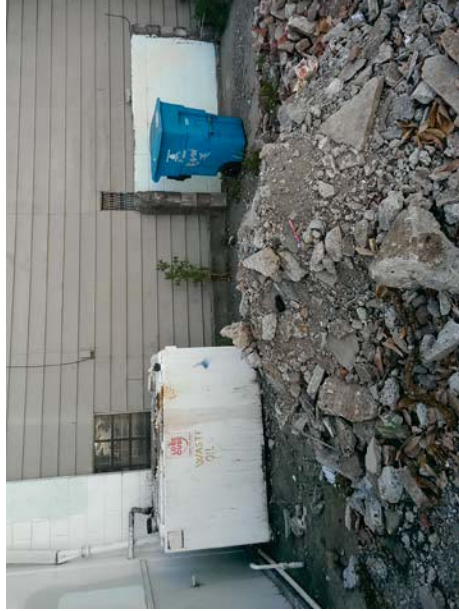
During the site reconnaissance, Rincon observed a small, empty, 6 foot by 4 foot used oil aboveground storage tank near the northwest corner of the onsite building. No other tanks were observed during the site reconnaissance. However, it was reported by the subject property representative that multiple USTs were located on the subject property in connection with the former use of the subject property as a gasoline station/mechanic shop. Although Rincon did not observe indications of releases from the tanks on the subject property, it was apparent that excavations had been conducted.

Photograph 5. View of the empty oil tank located near the northwest corner of the building.

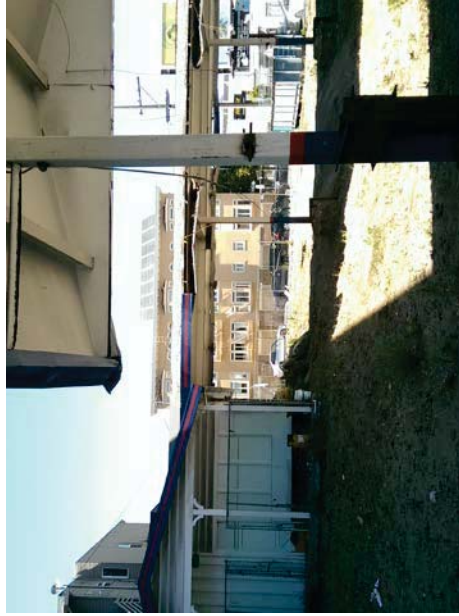
Stained Soil – Although no stained soil was observed on the subject property during the site reconnaissance, it was reported that impacted soil from a release of gasoline was excavated and disposed offsite. The release case received closure from the San Francisco Department of Public Health.

- A. *Former use of the subject property as a gasoline station/auto repair shop and former release of gasoline on the subject property (former industrial use)* – According to the records reviewed, the subject property was used as a gasoline station from 1936 to 1983, when it was converted to an auto repair facility. A release of gasoline occurred in September 1998 in connection with holes observed in the USTs on the subject property. Contaminated soil and groundwater were disposed offsite and the case was closed in March 2013. Residual contamination remains on the subject property, but not at levels reported to warrant mitigation. However, if the property is to be redeveloped, the San Francisco Department of Public Health recommends that if groundwater is encountered, that groundwater should be reevaluated for TPH prior to discharge to the sewer system. However, based on the fact that known contamination remains onsite, the former release of gasoline on the subject property is considered a REC.

Photograph 6. View of the subject property showing area which has been previously remediated.

Based on the known residual contamination on the subject property associated with the former use of the subject property as a gasoline station/auto repair shop and former release of gasoline on the subject property, Rincon recommends oversight by SFDPH and preparation of a Soil Management Plan/Remedial Action Plan prior to any redevelopment activities on the subject property. The Remedial Action Plan should describe the procedure to handle the known impacted soil on the subject property, and the Soil Management Plan should describe the procedure to handle unexpected issues such as underground features, wells, etc. In addition, based on the location of the subject property within a Maher Ordinance Area and potential presence of fill onsite, direct communication with the SFDPH would be required.
