## PHASE II SUBSURFACE INVESTIGATION REPORT

2500-2550 Irving Street, San Francisco, California 94122

ALLWEST PROJECT 19086.23.1  
August 19, 2019

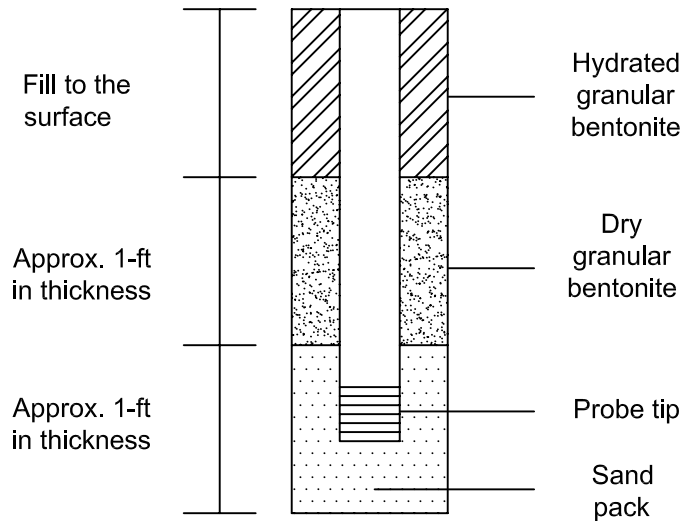
**Figure 1**  
**Permanent/Semi-permanent**  
**Gas Probe**  
**Construction**

Plastic or stainless steel soil vapor probes, ½-inch diameter by 2-inches long and tipped with porous plastic membranes, are then inserted to the bottom of the 1-inch diameter boreholes at 5 feet bgs. The probe tips are attached to 7-foot lengths of flexible 0.25-inch OD polyethylene, Nylaflo™ or Teflon™ tubing extending to the top of the floor slab. Only Teflon™ sample tubing is to be used if naphthalene analysis is intended. A 1-foot interval of fine sand filter pack is placed in the borehole annulus around the probe, typically from approximately 4.5 to 5.5 feet bgs. A 1-foot interval of the annular space above the filter pack is then filled with non-hydrated granular bentonite. Hydrated granular bentonite or bentonite chips are then used to fill the annular space above the non-hydrated granular bentonite to the top of the floor slab or surface pavement. The bentonite is allowed to hydrate and borehole conditions to equalize for 2 hours prior to sampling activities, per DTSC vapor sampling guidelines. Temporary soil vapor probe installation procedures will be performed in general accordance with guidelines presented in the DTSC *Advisory – Active Soil Gas Investigations*, July, 2015.

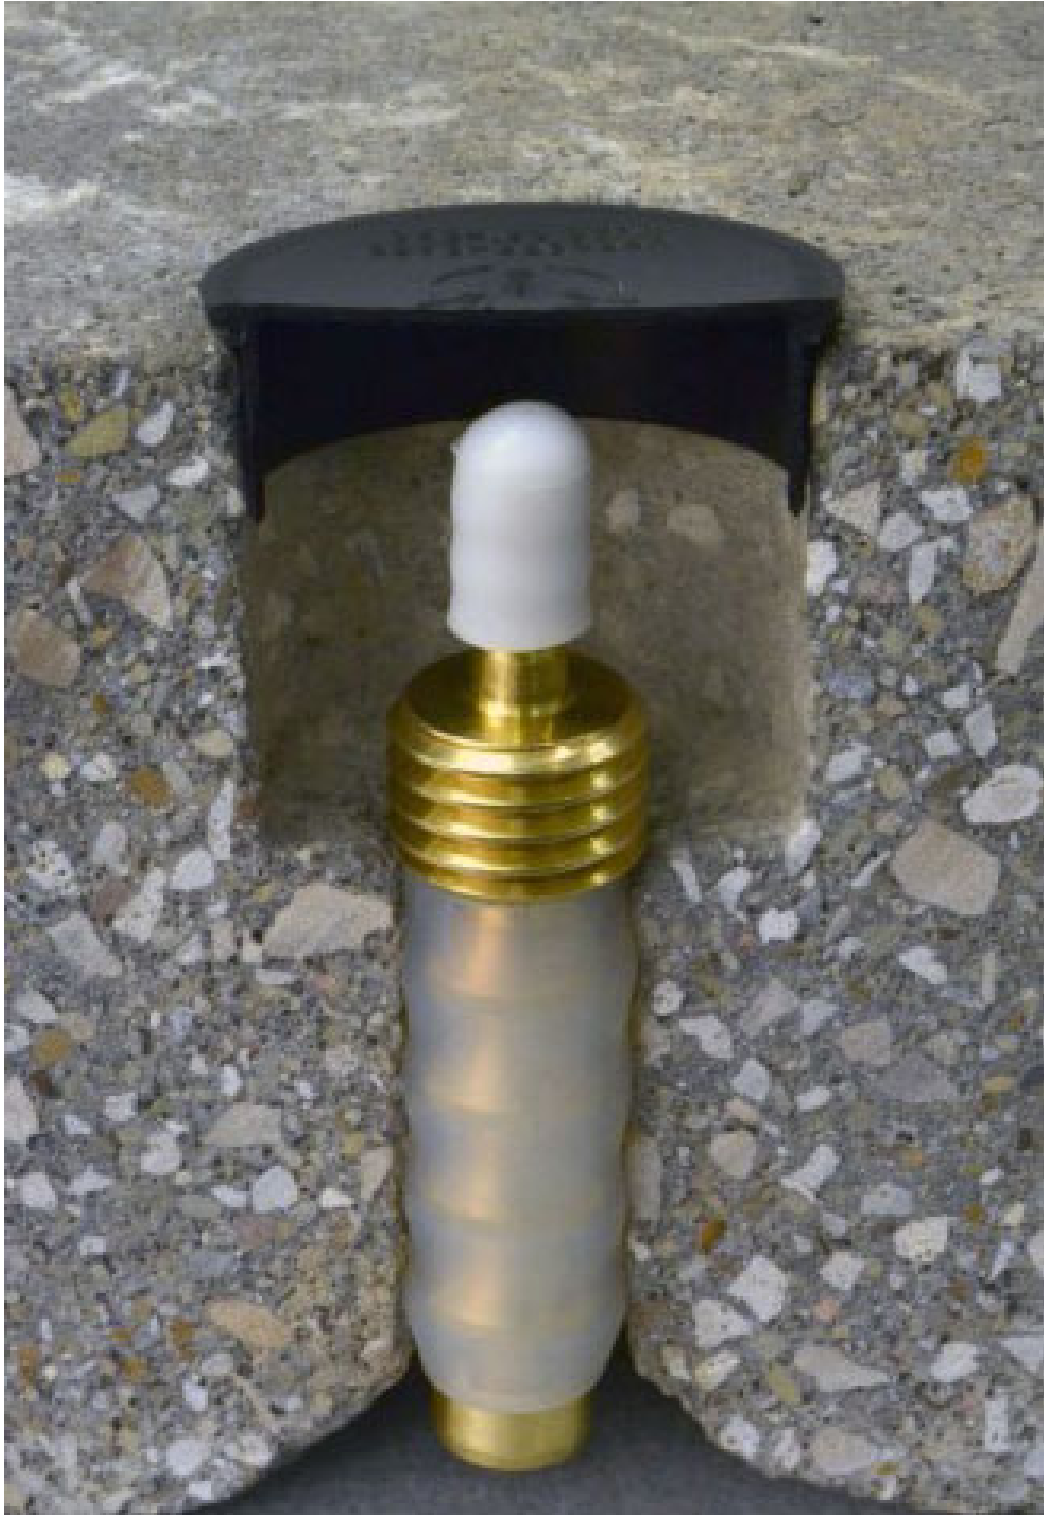
## **Sub-Slab Cox-Colvin Vapor Pin<sup>®</sup> Installation Sectional View**

For flush mount installations, unscrew the threaded coupling from the installation/extraction handle and use the hole in the end of the tool to assist with the installation. During installation, the silicone sleeve will form a slight bulge between the slab and the Vapor Pin™ shoulder. Place the protective plastic cap on the Vapor Pin™ barbed fitting to prevent vapor loss prior to sampling. For flush mount installations, cover the Vapor Pin™ with a threaded metal flush mount cover. Allow 2 hours or more (per DTSC sub-slab vapor sampling guidelines) for the sub-slab soil-gas conditions to equilibrate prior to sampling.
