Date: 14 September 2017

Project: 801 Brannan Street – MOH Parcel
San Francisco California
Langan Project No. 731615201
SMED No.985

Subject: MOH Parcel Temporary Cap Amendment

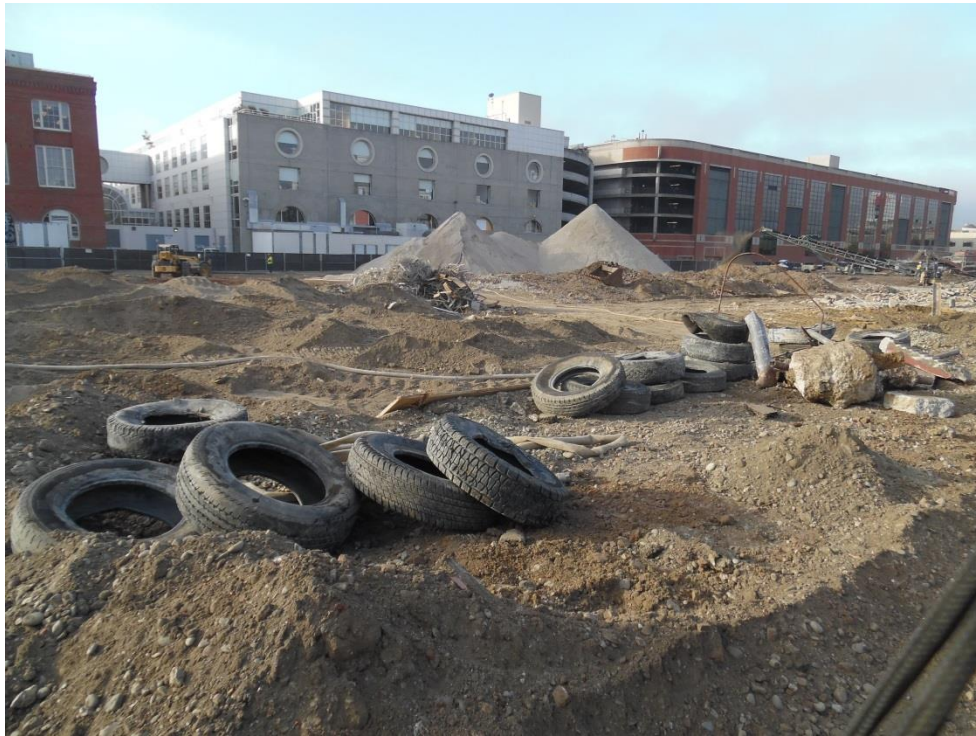
Photograph 1: 5/11/15 – Facing south. Concrete crusher operated by Ferma Corporation Crushed concrete piles that was used as the temporary cap material. Concrete piles are light grey in color compared to the brown earthquake fill.

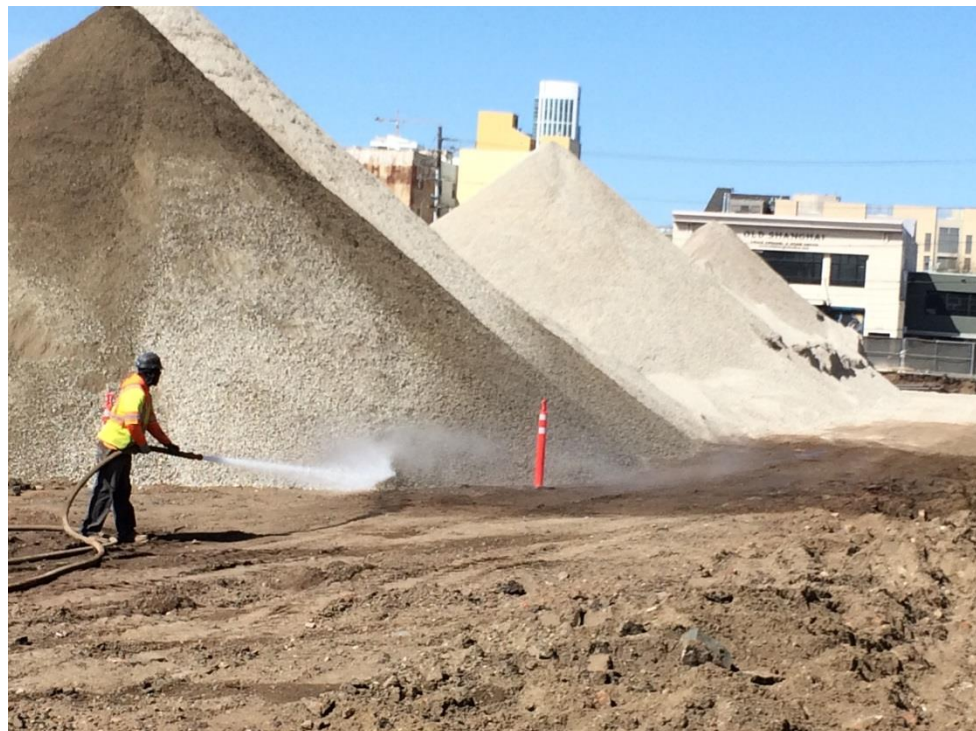
Photograph 2: 5/12/15 – Facing north. Close-up of crushed concrete piles that was used as cap material.

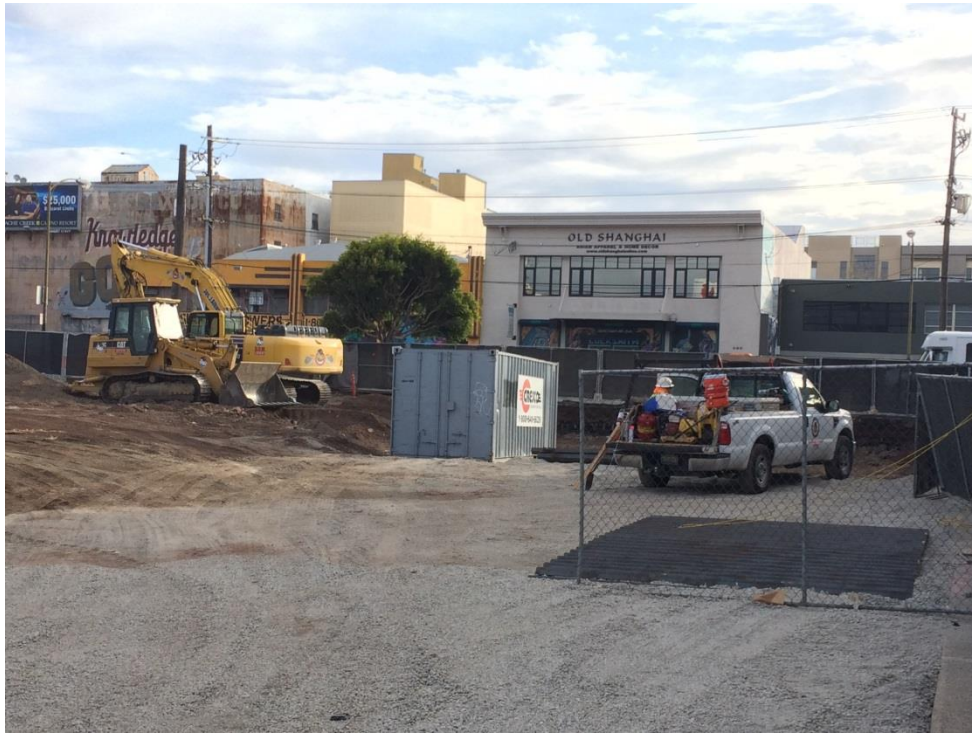
Photograph 3: 5/13/15 – Facing northeast. Gravel is placed prior to asphalt paving.

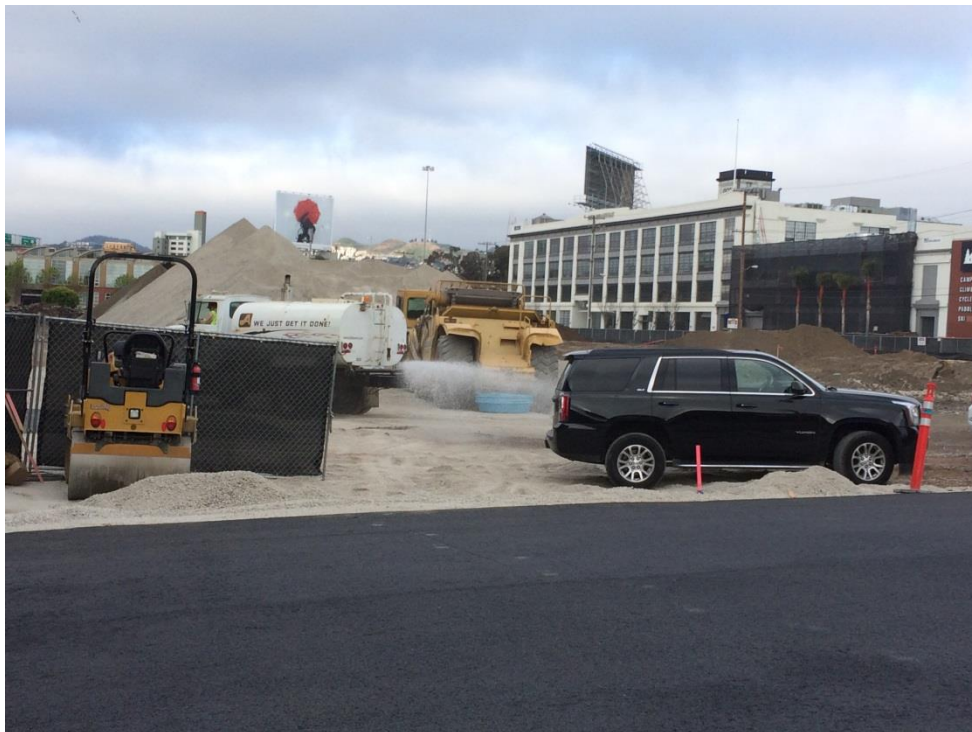
Photograph 4: 5/15/15 – Facing west showing different colors of the asphalt parking lot (foreground), crushed concrete layer (west) and earthquake fill (northwest).

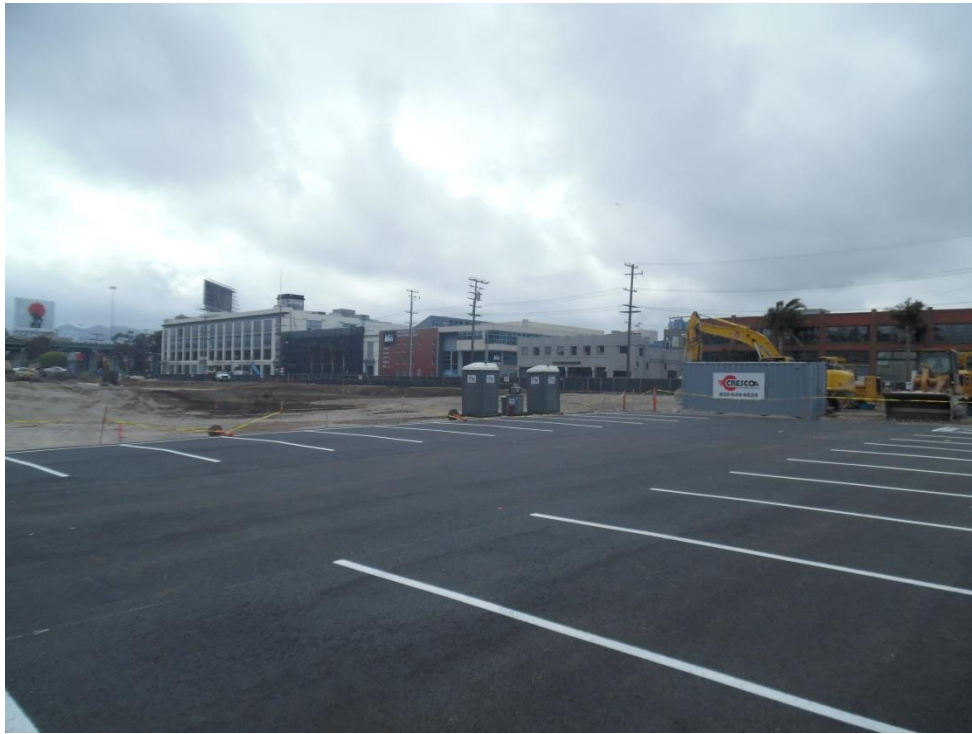
Photograph 5: 5/18/15 – Facing west showing completed asphalt parking lot, crushed concrete partially laid down for the part of the MOH parcel and the earthquake fill further northwest.

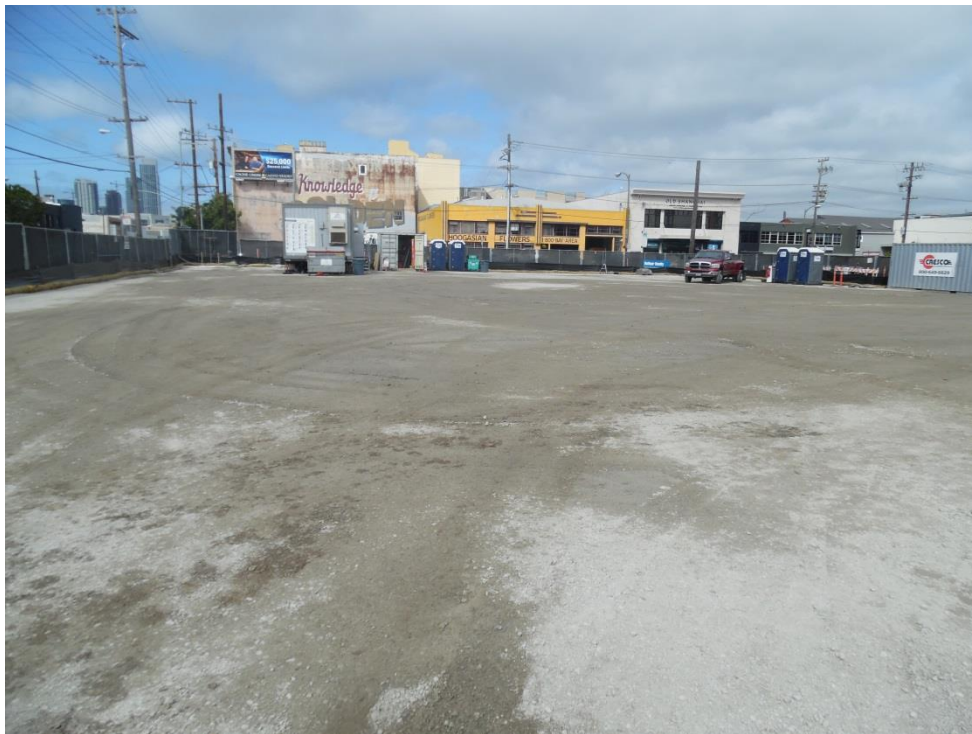
Photograph 6: 5/20/15 - Facing northeast illustrating crushed concrete layer over MOH parcel.

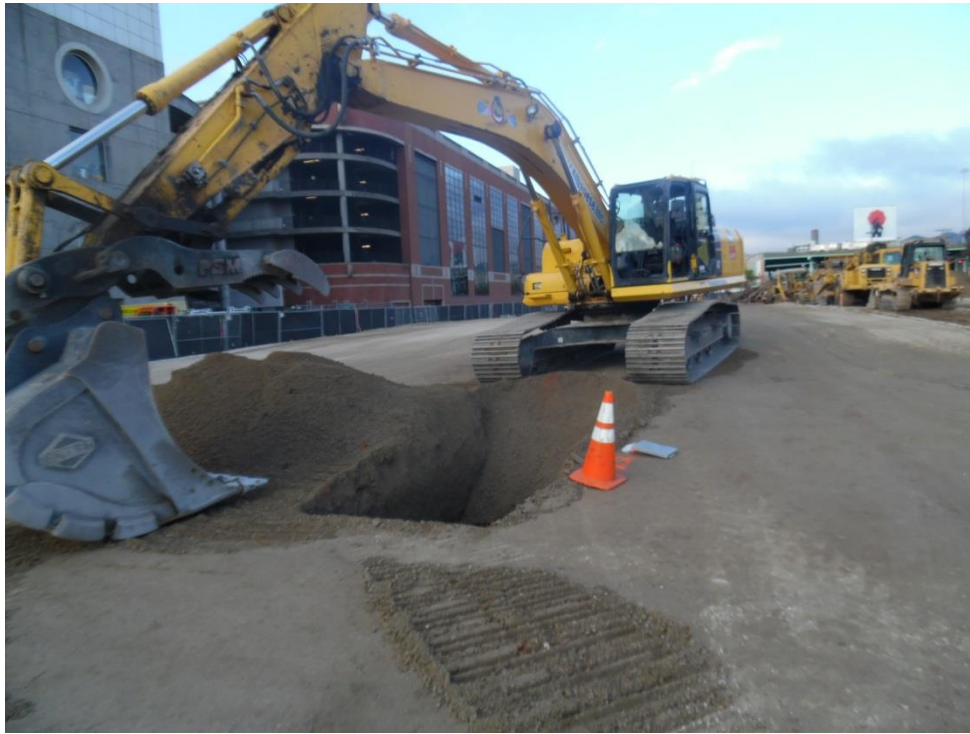
Photograph 7: 5/22/15 - Facing southeast. Excavated test pit for the collection of confirmation soil sample CS-2-05-22-15.

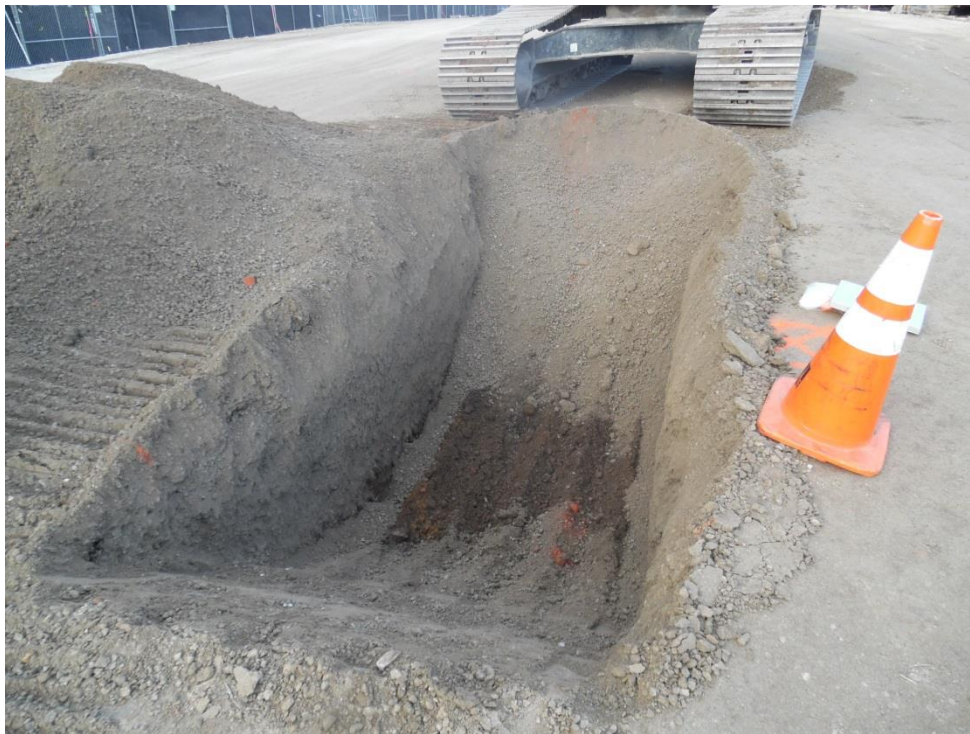
Photograph 8: 5/22/15 – Bottom of test pit from Photograph 6 showing the color and grade change between the crushed concrete cap material and the earthquake fill.

In April 2015 the MOH parcel demolition and grading activities were completed. In May 2015, the 2 foot temporary cap was placed and compacted on top of the fill material without a demarcation layer. In addition, two asphalt parking areas (8,008 and 6,120 sf) were constructed above the temporary cap to provide Balfour Beatty Construction with parking and construction staging areas. Photographs of the temporary cap placement are presented in Attachment 2. As presented in the photographs there is a distinct color and material grade change between the underlying fill material and the temporary cap. The observed color change is from brown to light grey and the grade changes from typical earthquake fill comprised of sand with varying amounts of silt, clay, gravel, concrete, brick, and wood fragments to crushed concrete. To mitigate the risk of direct contact with underlying soil, future development plans at the MOH will include removal of the temporary cap and construction of the SMP approved permanent cap which will include either 1) concrete building foundations 2) concrete paved walkways, or 3) a cap of 2 feet of clean soil underneath landscaped areas and areas covered with permeable pavers.
