1 **3.9 GEOLOGY AND SOILS**

3.9 Geology and Soils

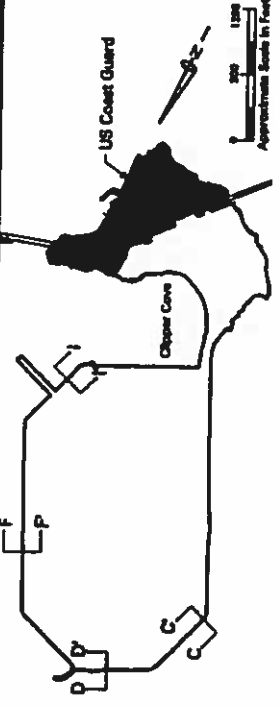
Representative Cross Sections on Perimeter Dikes at Treasure Island

- Well-graded sand
- Silty sand
- Poorly graded sand
- Clayey sand
- Low plasticity silt
- Low plasticity clay
- High plasticity clay
- Ground surface
- Lithologic contact
- Lithologic contact (location uncertain)
- Original ground surface

Cross sections illustrate that perimeter dikes are constructed on sand or fill materials.
