**PRELIMINARY GEOTECHNICAL INVESTIGATION  
GEOTECHNICAL DUE DILIGENCE  
BALBOA PARK BART UPPER YARD  
SAN FRANCISCO, CALIFORNIA**

Subject: Preliminary Geotechnical Investigation  
Geotechnical Due Diligence  
Balboa Park BART Upper Yard  
San Francisco, California

This letter transmits our preliminary geotechnical investigation report for the Balboa Park BART Upper Yard site in San Francisco, California. The work described in this report was performed in accordance with our proposal dated 29 January 2013.

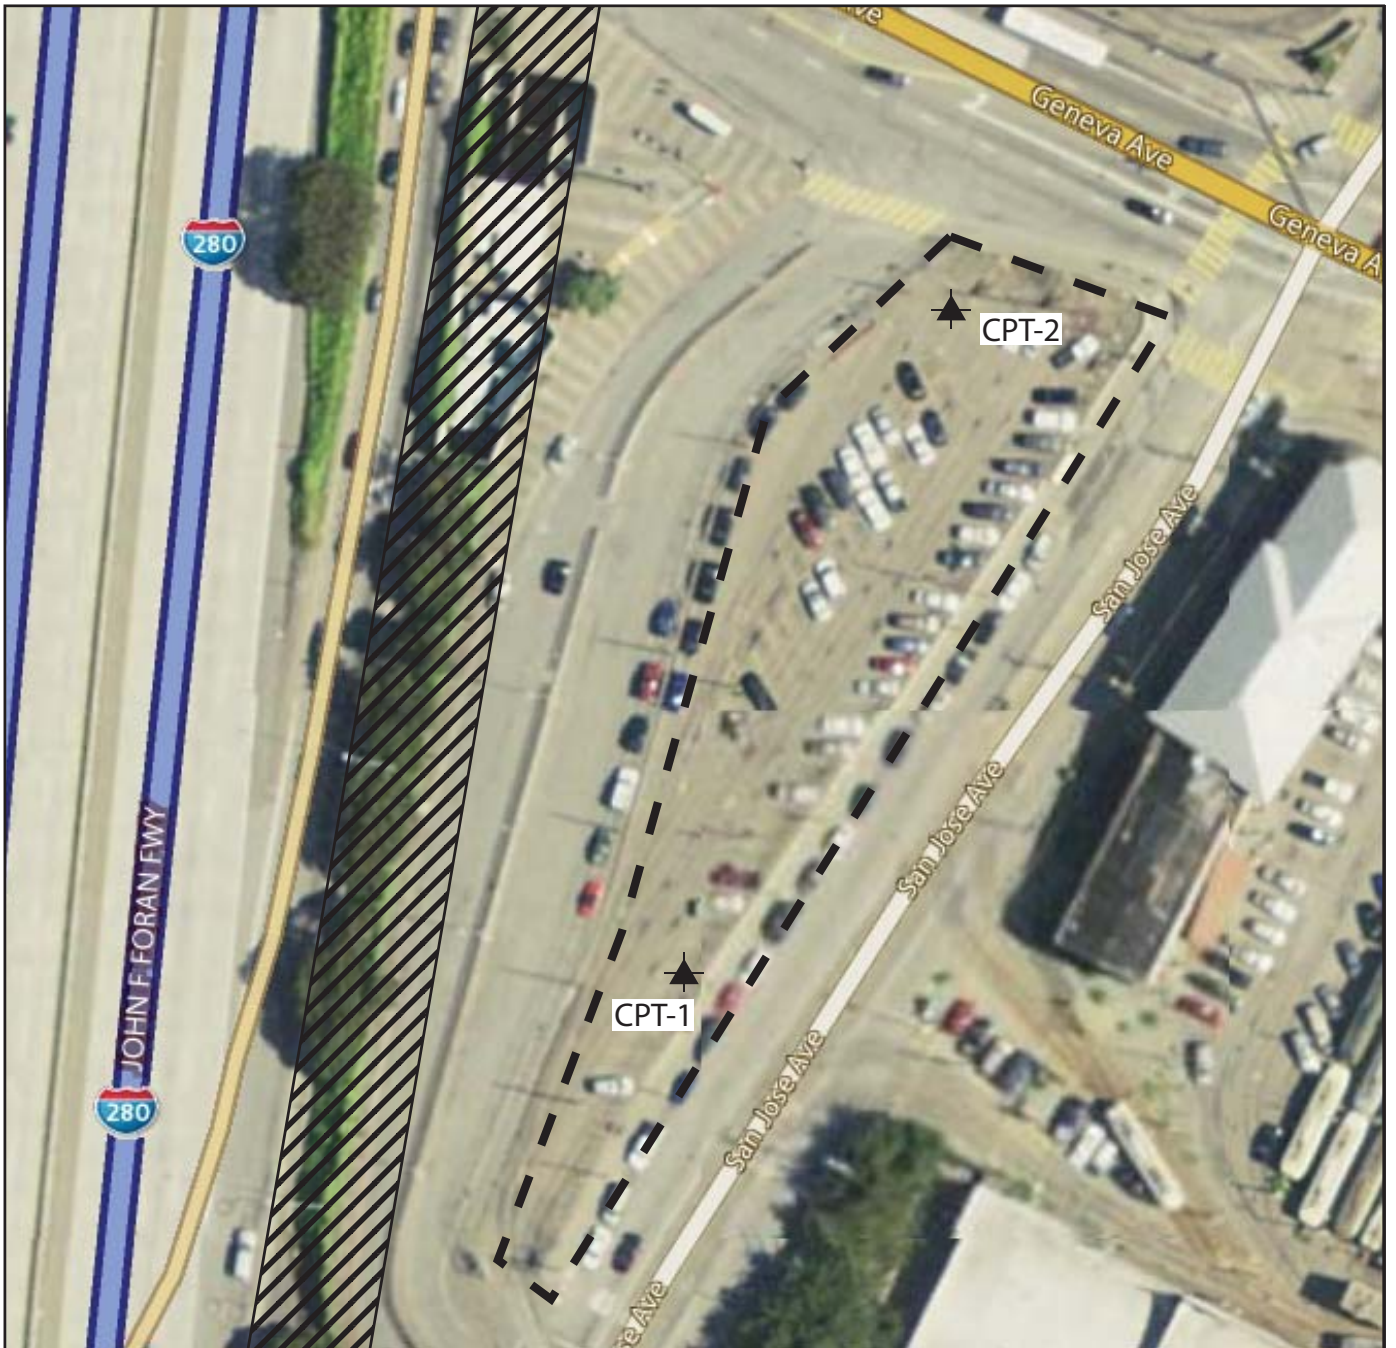
Date 5/31/13    Project No. 13-050202    Figure 2

CPT-1    Approximate location of cone penetration test performed by DC/RG JV, 29 March 2013

We explored subsurface conditions at the site by advancing two CPTs (CPT-1 and CPT-2) at the approximate locations shown on Figure 2. The CPTs were performed on 29 March 2013, by Gregg Drilling. CPT-1 and CPT-2 were advanced to practical refusal in cemented sands at depths of approximately 20 and 27 feet bgs, respectively.

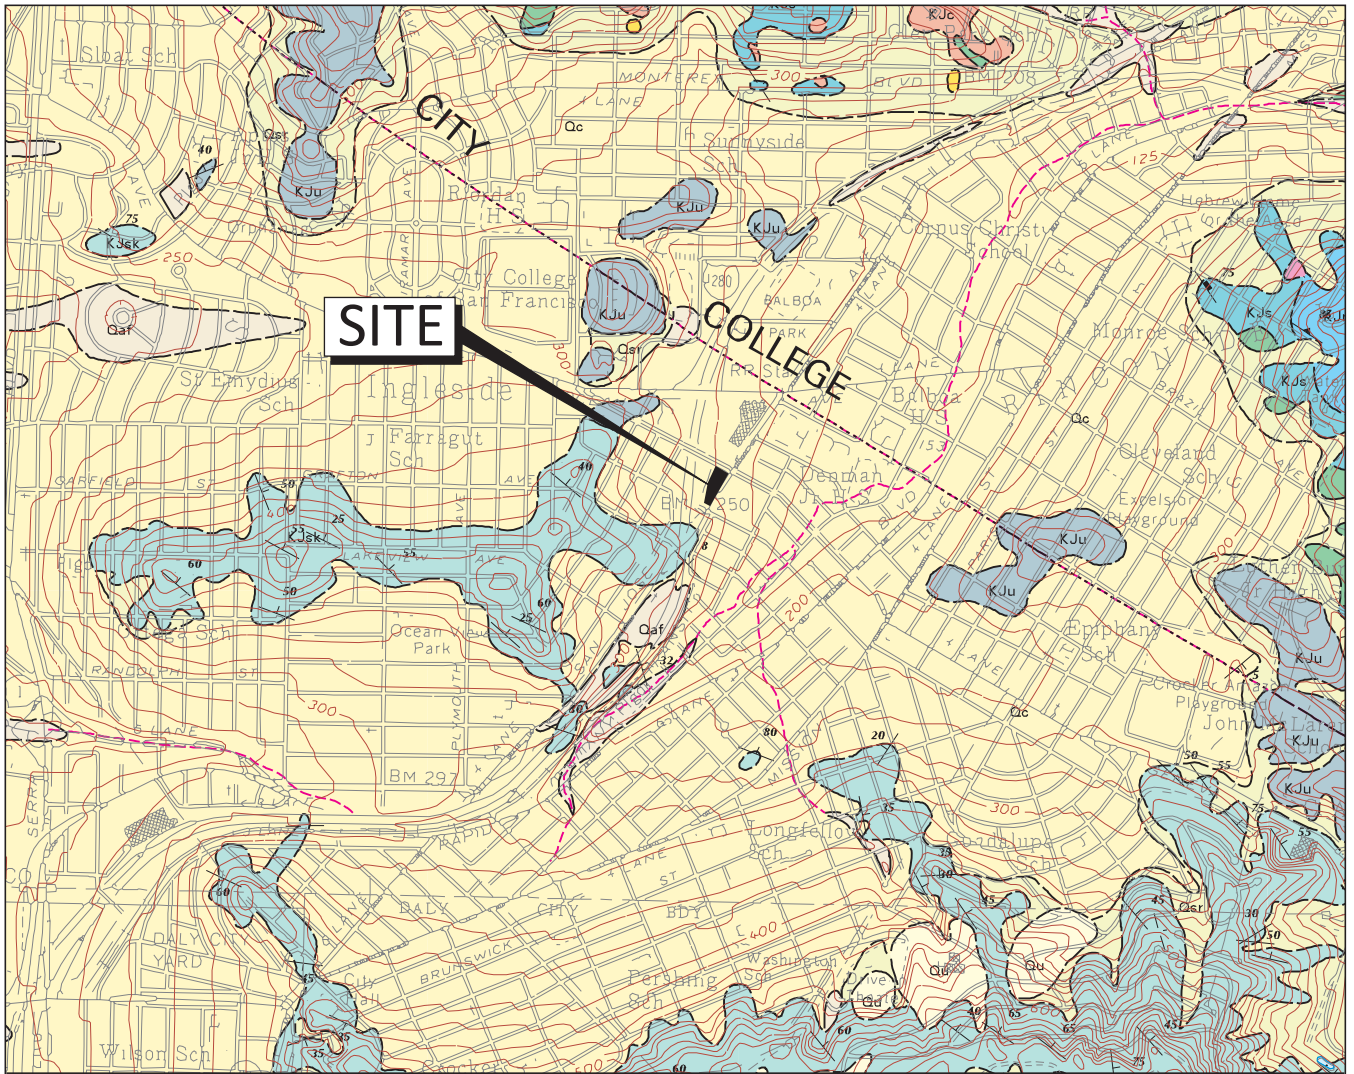
- Qaf Artificial fill
- Qc Colma formation
- Qsr Slope debris and ravine fill
- Qu Sedimentary deposits, undifferentiated
- KJs Sandstone and shale
- KJc Chert
- KJg Greenstone
- KJsk Sandstone and shale
- KJu Sheared rocks
- Contact, approximately located
- 1800s shoreline and stream channels

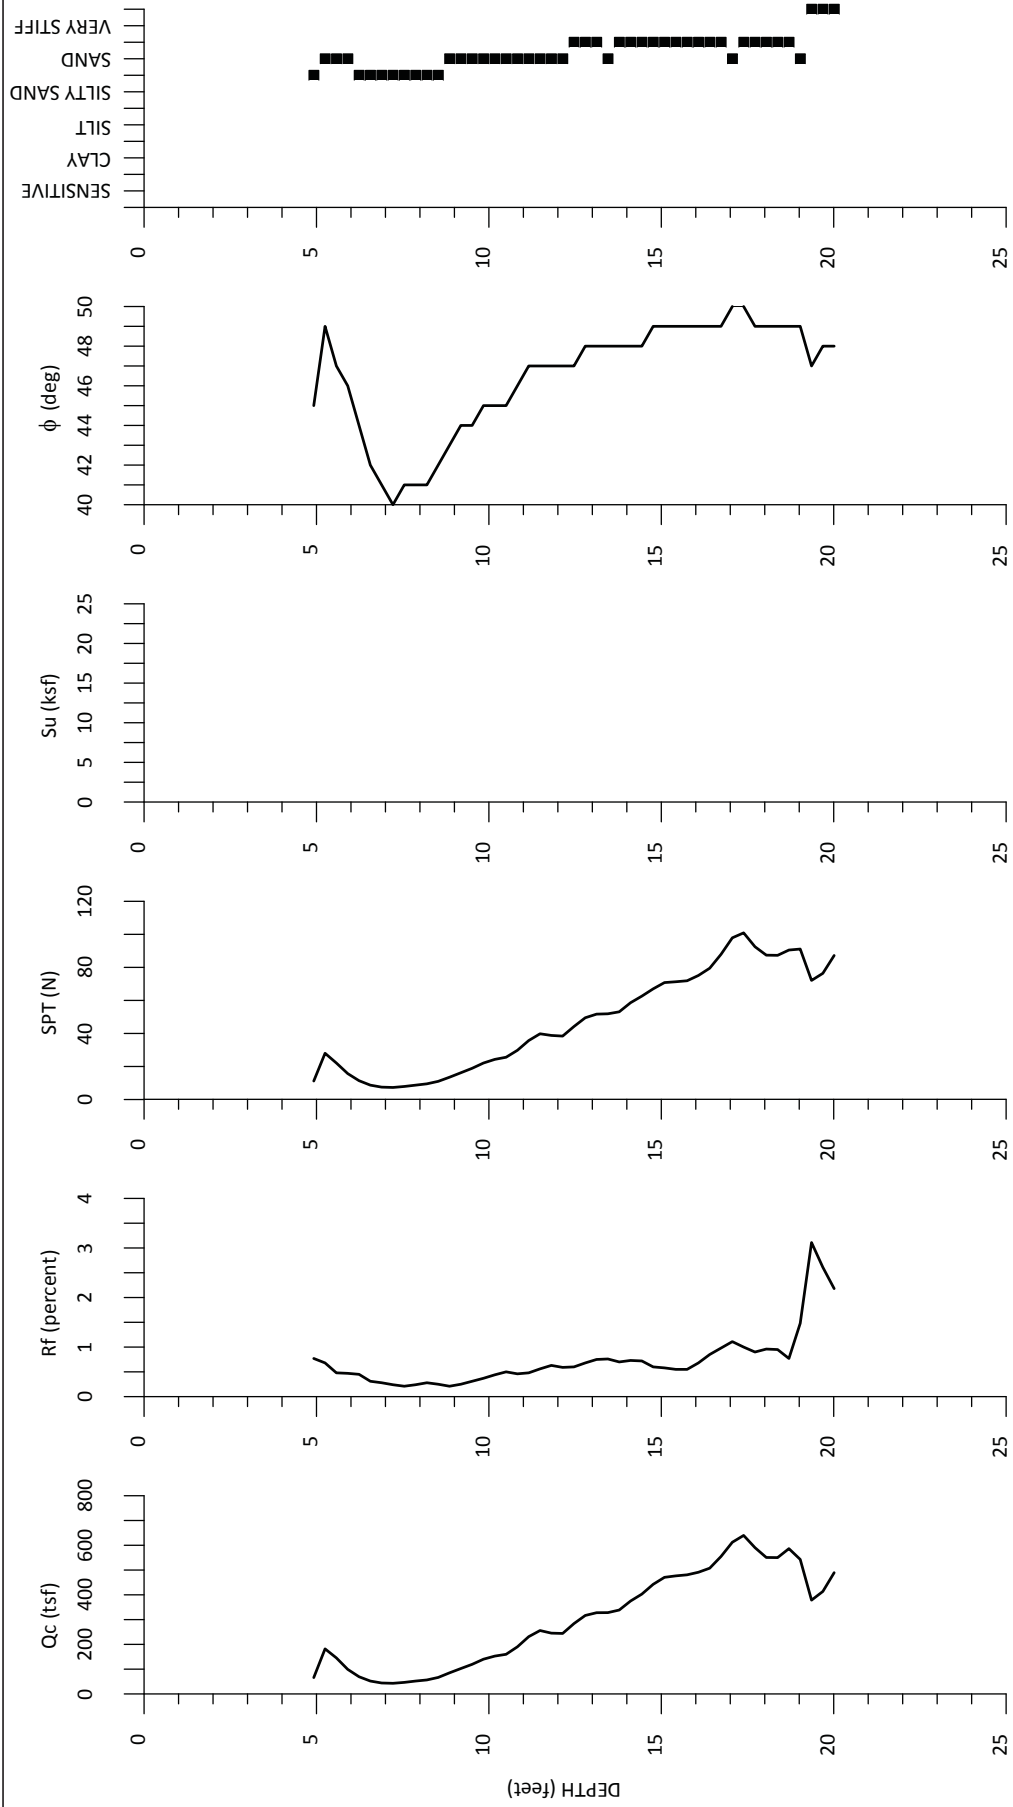
**CPT-1**

Terminated at 20 feet  
Groundwater measured at 10 feet.  
Date performed: 3/29/13

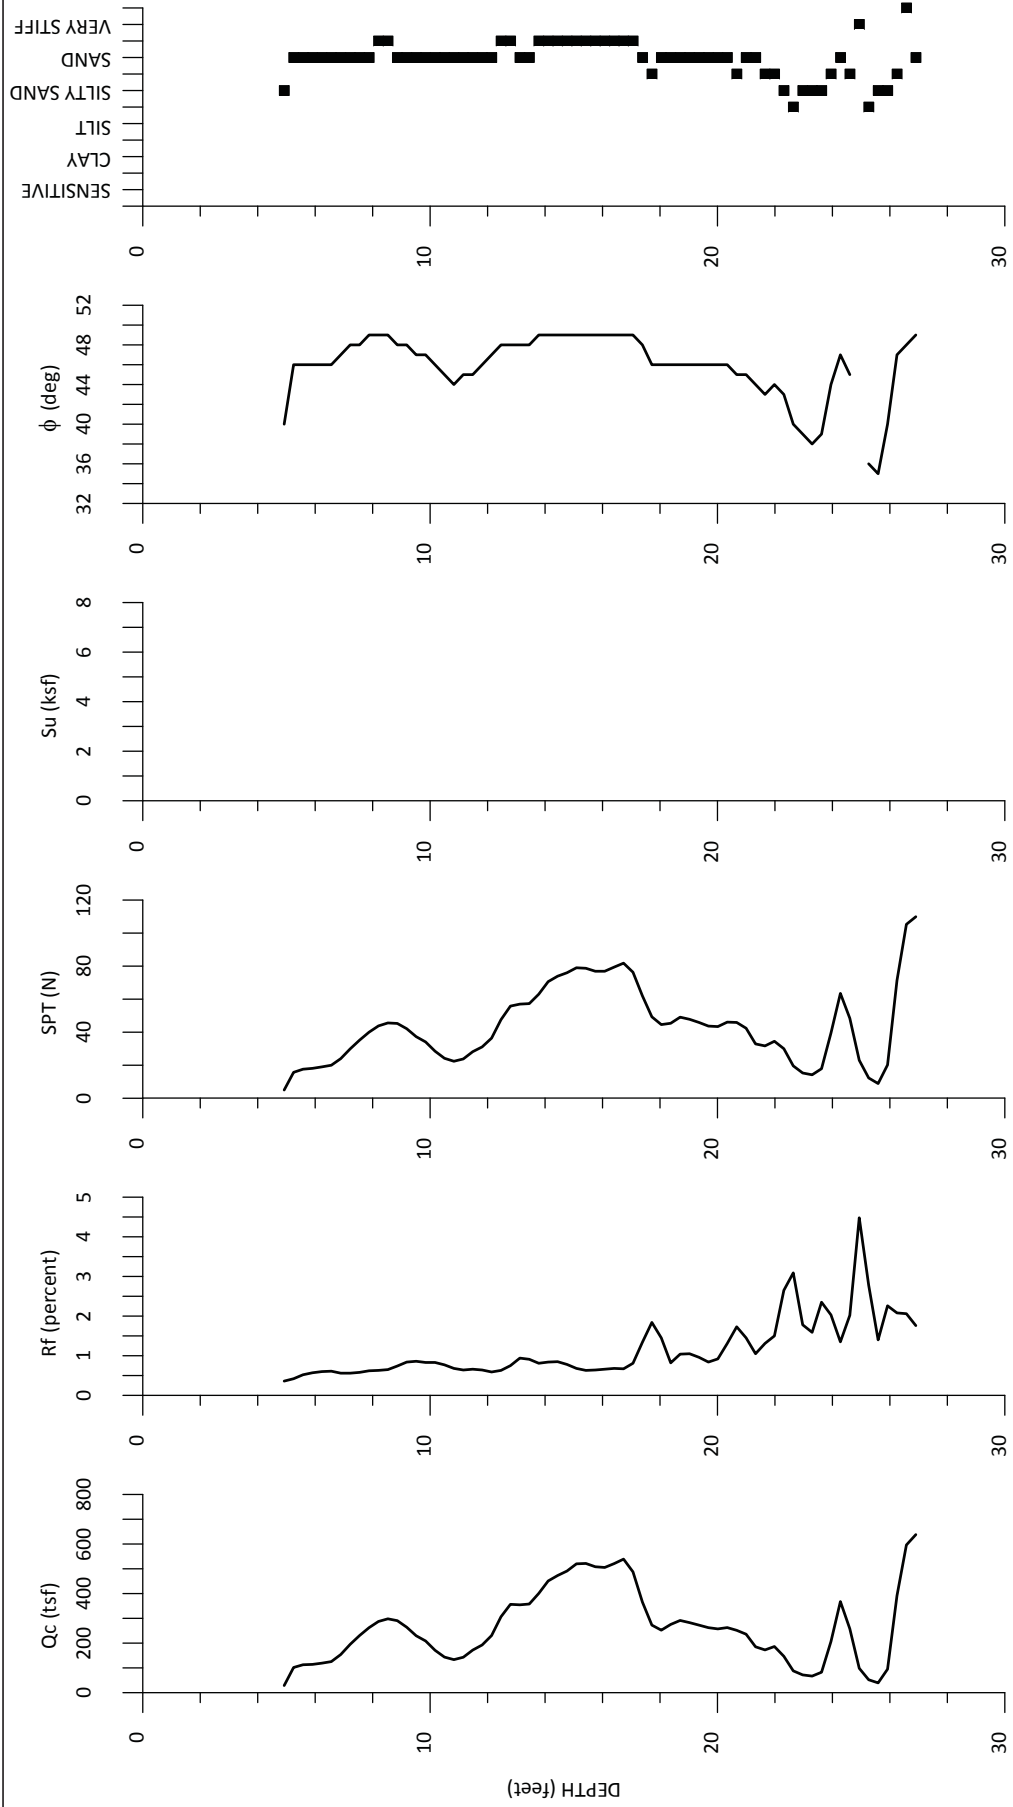
**CPT-2**

Terminated at 20 feet  
Groundwater measured at 10 feet.  
Date performed: 3/29/13

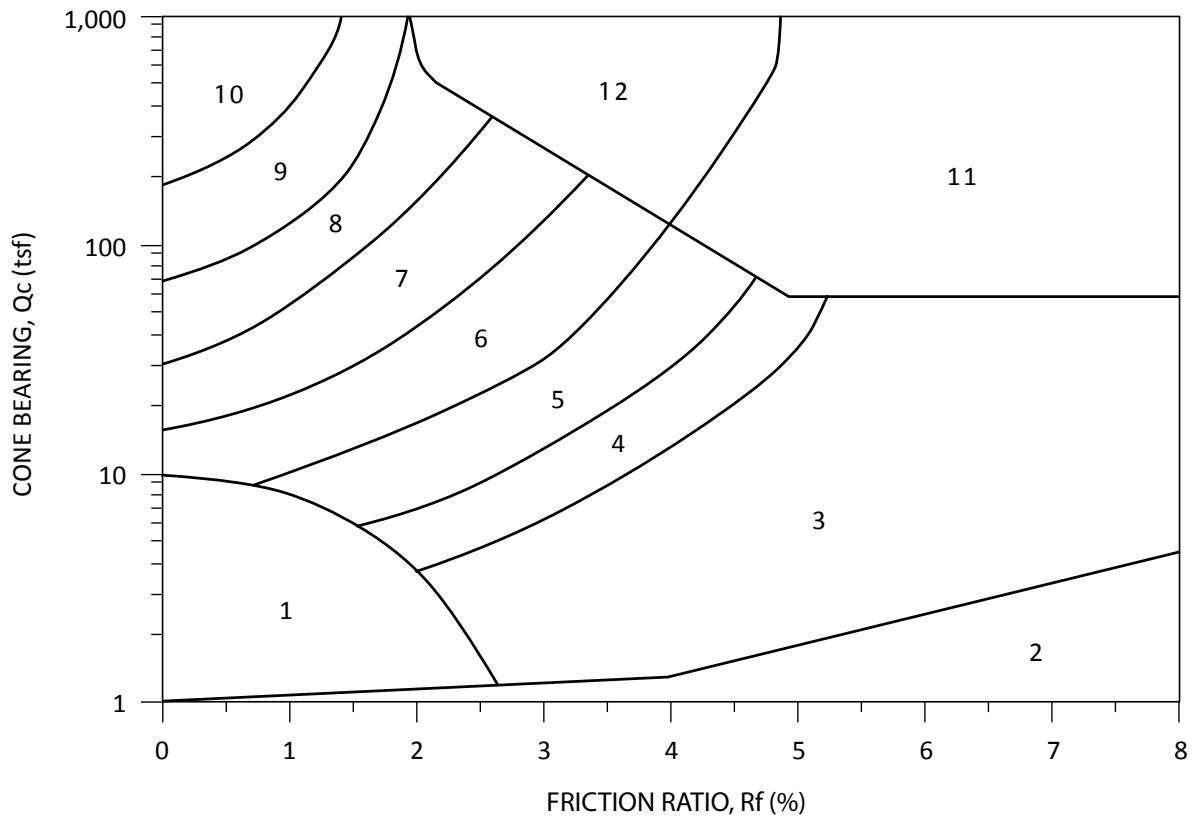
ZONE	Qc/N <sup>1</sup>	Su Factor (Nk) <sup>2</sup>	SOIL BEHAVIOR TYPE <sup>1</sup>
1	2	15 (10 for Qc 9 tsf)	Sensitive Fine-Grained
2	1	15 (10 for Qc 9 tsf)	Organic Material
3	1	15 (10 for Qc 9 tsf)	CLAY
4	1.5	15	SILTY CLAY to CLAY
5	2	15	CLAYEY SILT to SILTY CLAY
6	2.5	15	SANDY SILT to CLAYEY SILT
7	3	---	SILTY SAND to SANDY SILT
8	4	---	SAND to SILTY SAND
9	5	---	SAND
10	6	---	GRAVELLY SAND to SAND
11	1	15	Very Stiff Fine-Grained (*)
12	2	---	SAND to CLAYEY SAND (*)

(\*) Overconsolidated or Cemented  
 Qc = Tip Bearing  
 Fs = Sleeve Friction  
 Rf = Fs/Qc x 100 = Friction Ratio

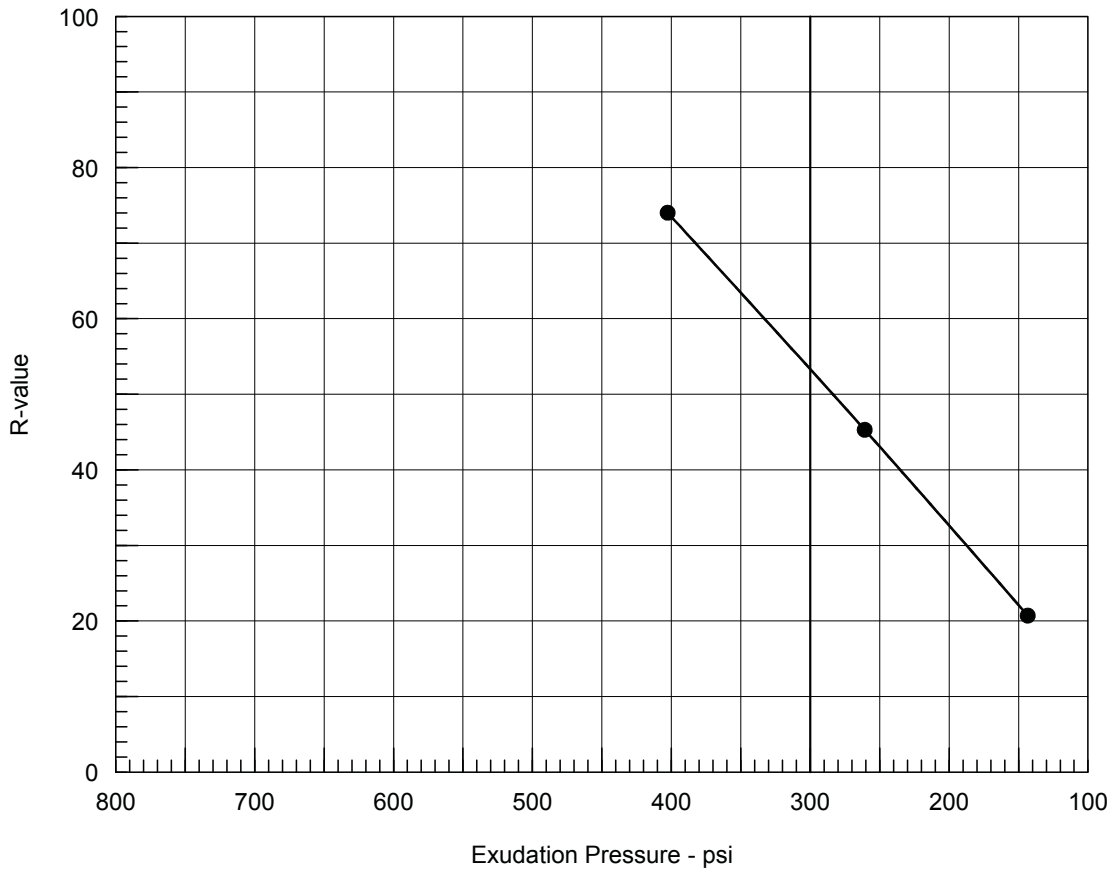
# R-VALUE TEST REPORT

## Resistance R-Value and Expansion Pressure - Cal Test 301

No.	Compact. Pressure psi	Density pcf	Moist. %	Expansion Pressure psi	Horizontal Press. psi @ 160 psi	Sample Height in.	Exud. Pressure psi	R Value	R Value Corr.
1	200	135.6	7.7	0.00	116	2.49	143	21	21
2	350	127.7	5.9	0.00	32	2.53	403	74	74
3	300	136.2	7.0	0.00	71	2.41	261	48	45
